REPORT OF FACILITY CONDITION ASSESSMENT

Brevard Elementary

Prepared By:
Axias
Project No. GA23-017
February 26, 2024

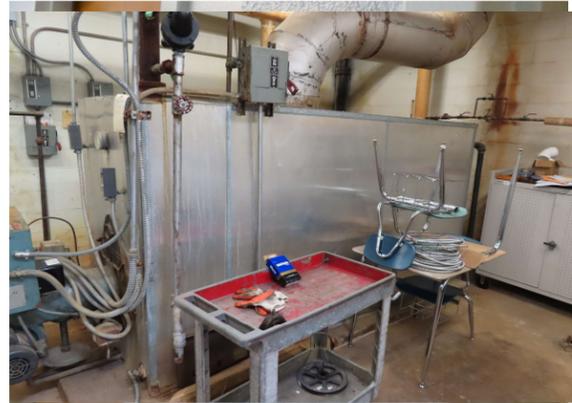
3	Burman boiler is from approximately 2001 and it is at the end of its useful life based on age.	Replace 2001 Burnham Boiler along with the pumps, valves, and accessories..	III	CR	3	3	4	4	14	Medium	25	3	3,584	MBH	\$85			\$304,640								\$304,640
4	Air handling units provided conditioned air to the various areas of the building. The units were manufactured by McQuay, Trane and Environmental Technologies. The units appeared to be in fair condition but should be budgeted for replacement during the study period.	Replace air handling units throughout the building.	III	CR	3	3	4	4	14	Medium	25	5	9	EA	\$35,000					\$315,000						\$315,000

Main heating hot water boiler.

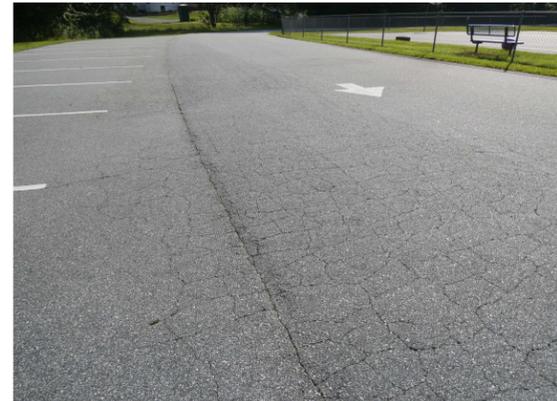
Asphalt with alligator cracking

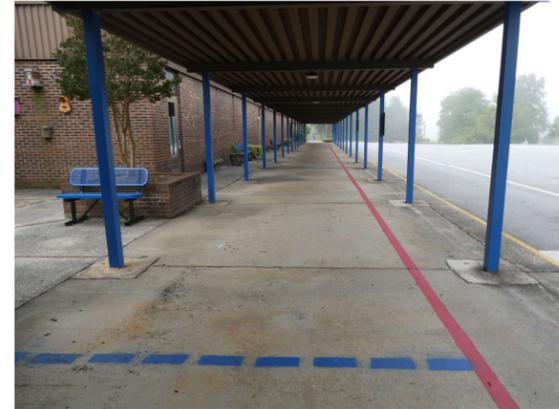
Drop off area with profilled metal awning structure and damaged poles.

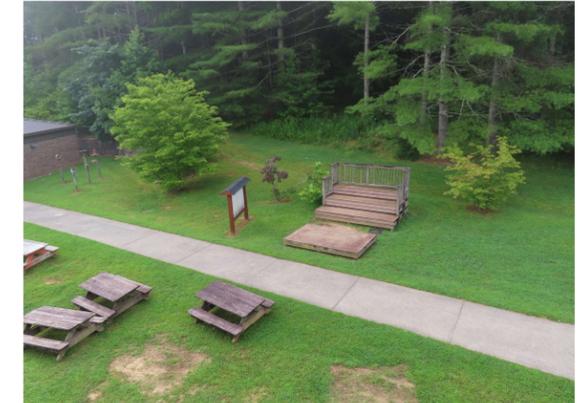
Overview of site

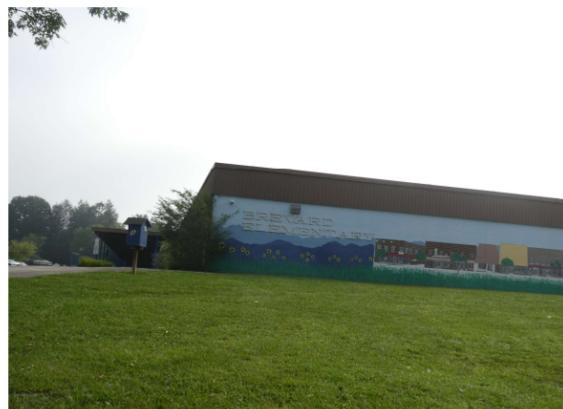
Entrance side of standing seam metal sloped roof and brick masonry exterior

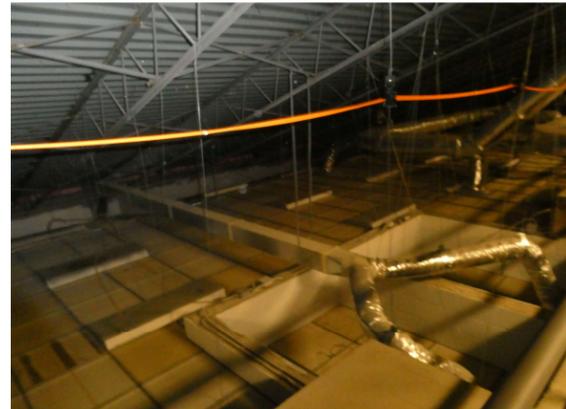
Steel frame and metal roof structure

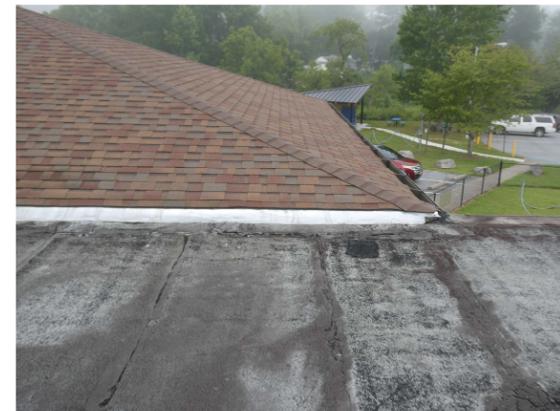
Asphalt shingle and modified bitumen low-slope roof

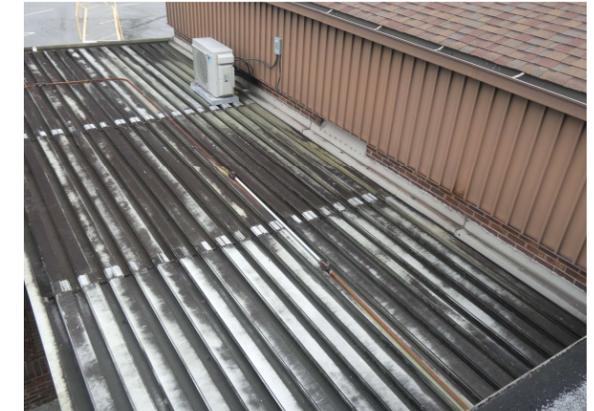
Standing seam metal roof canopy

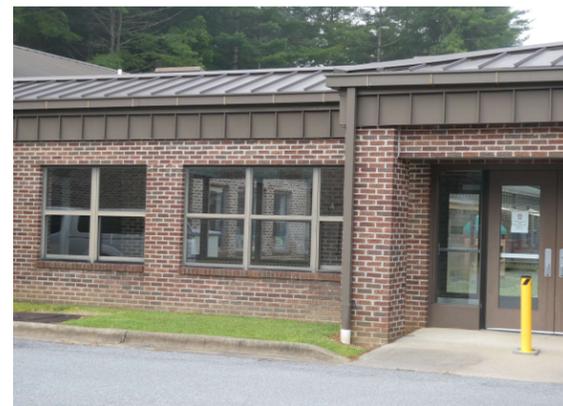
Brick masonry exterior wall and aluminum framed windows

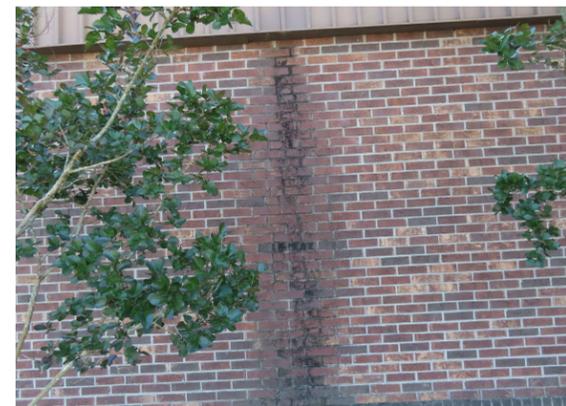
Exterior brick masonry and staining to brickwork

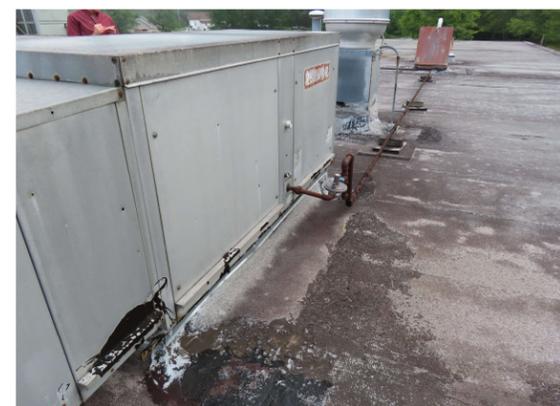
Reznor MUA unit

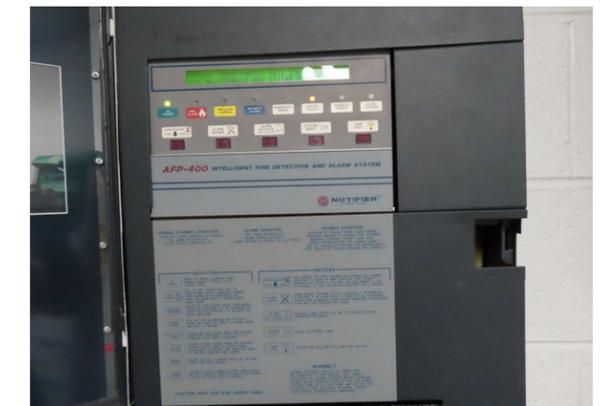
Notifier fire alarm control panel (FACP) that is obsolete.
