# REPORT OF FACILITY CONDITION ASSESSMENT

## Brevard High School

Project No. GA23-017

February 26, 2024

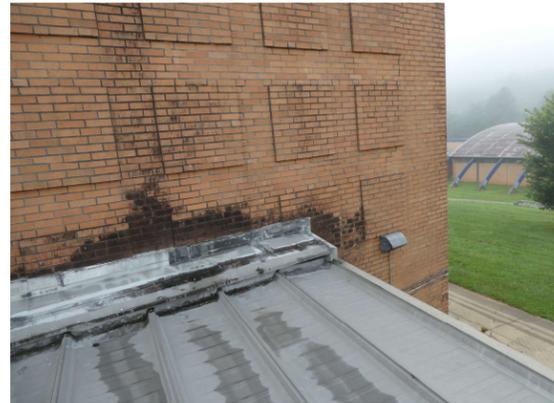
Area of water ingress at Auditorium

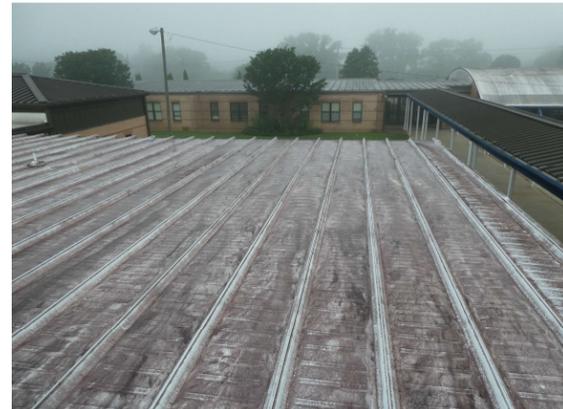
Original standing seam metal roofs

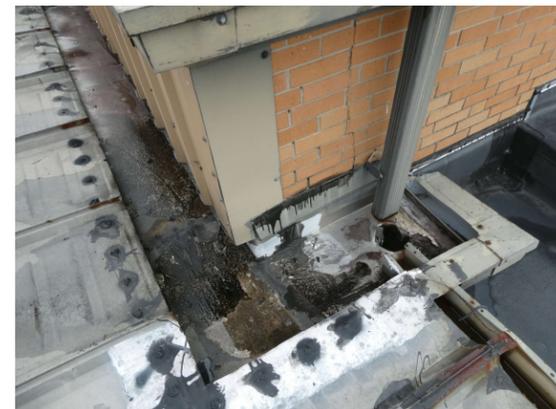
Poor drainage detailing and area of persistent water ingress

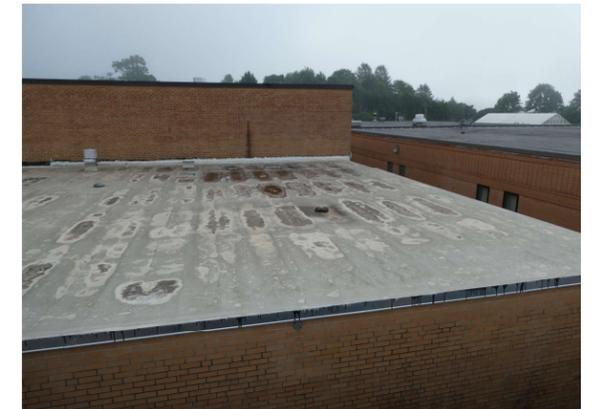
Roof covering at EC Wing in poor condition

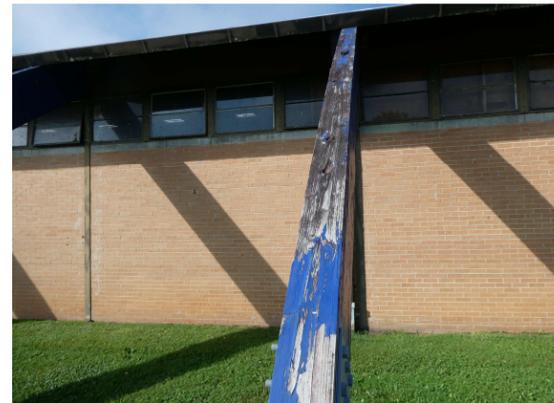
Deteriorated paint finishes at glulam beams at Old Gym

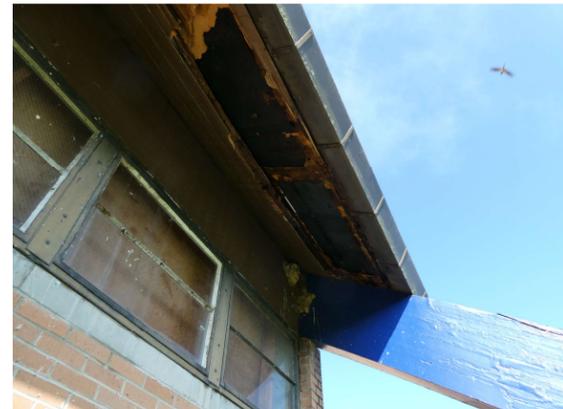
Failed and missing roof deck at Old Gym

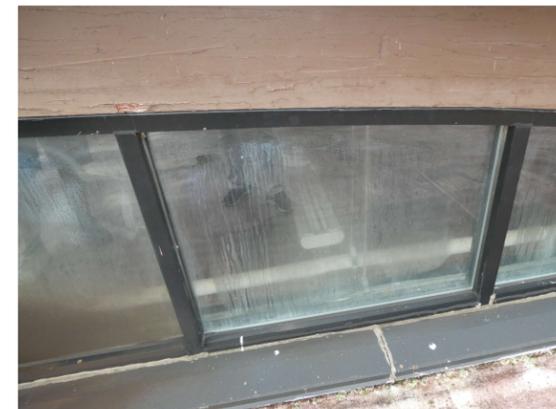
Fogged glazing at Cafeteria roof

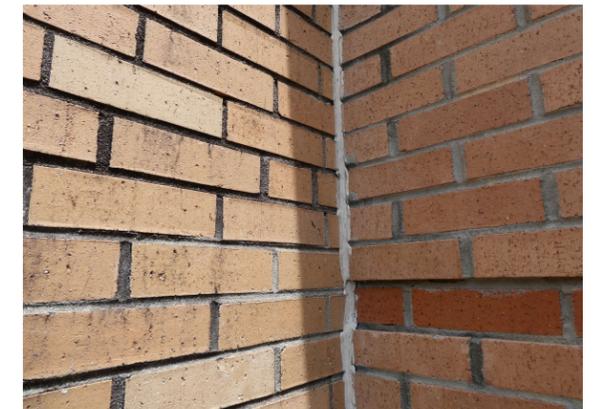
Sealant joints in brickwork in poor condition

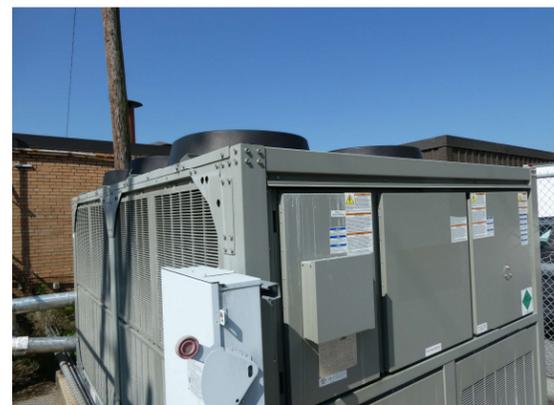
Pad mounted chiller

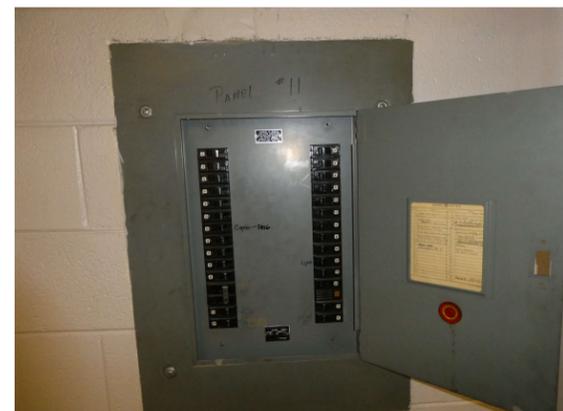
Older electrical equipment

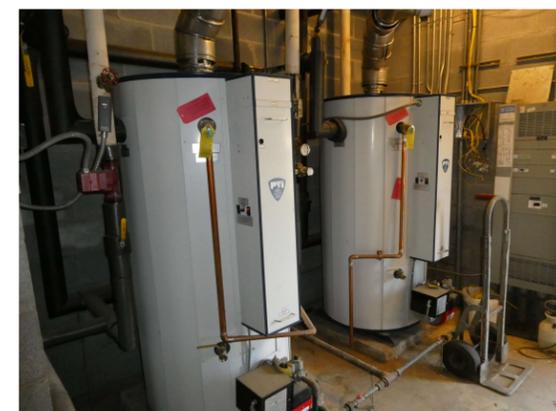
Domestic water heaters

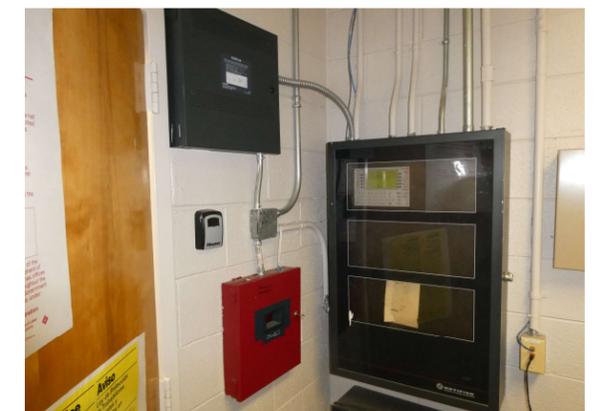
Fire alarm control panel
