REPORT OF FACILITY CONDITION ASSESSMENT

Davidson River School

Property Address:
970 Ecusta Road
Brevard, NC 28712

Prepared By:
Axias
Project No. GA23-017
February 26, 2024

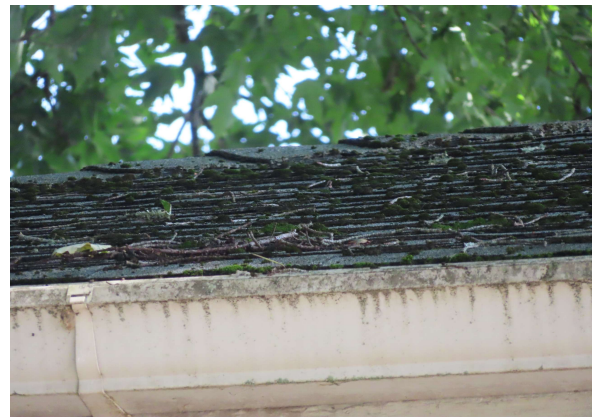
Organic growth at asphalt shingles.

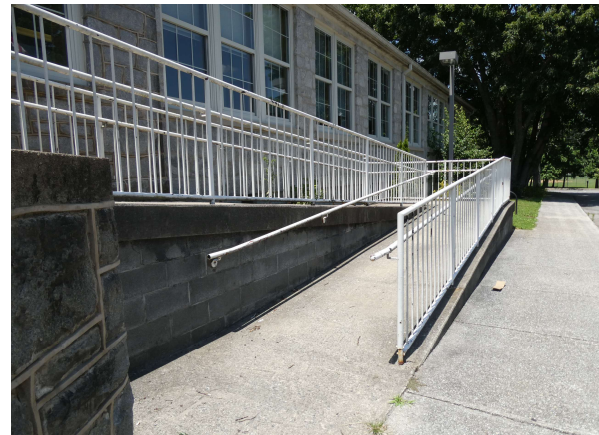
Exterior view of entrance ramp with guardrail.

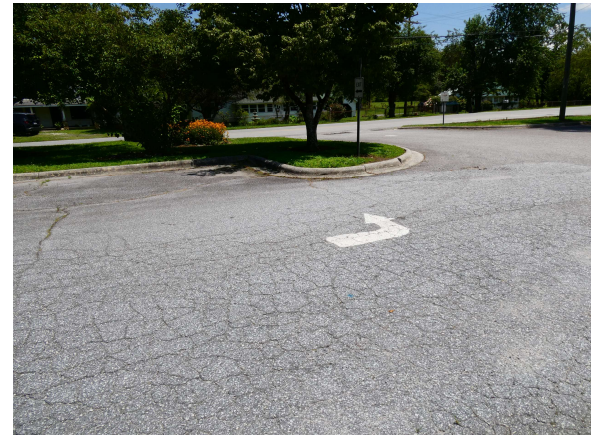
Alligator cracking of asphalt parking lot.

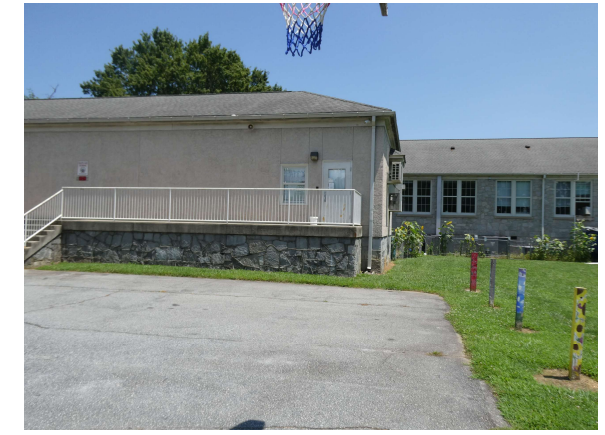
Modular unit addition with stucco exterior.

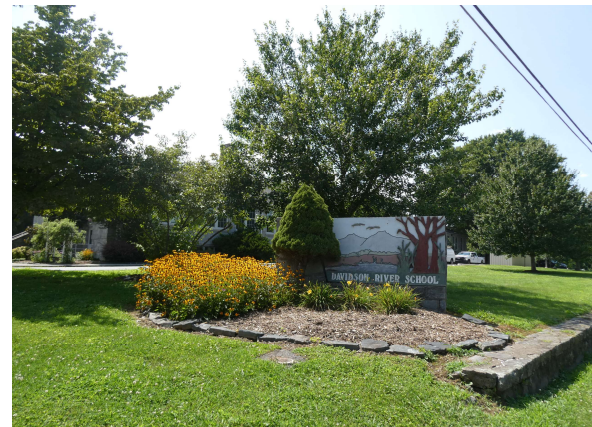
Front view of signage and low retaining wall.

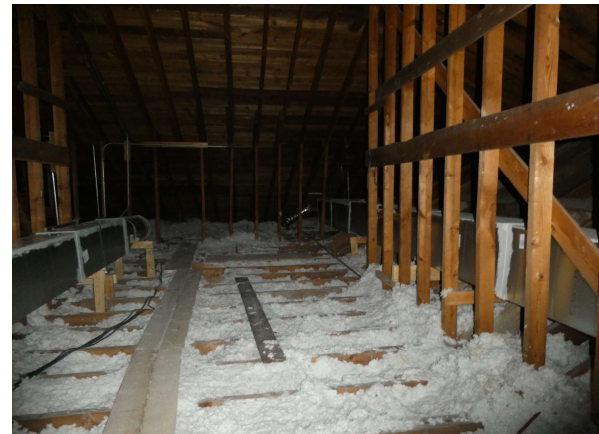
Architectural wood frame structure.

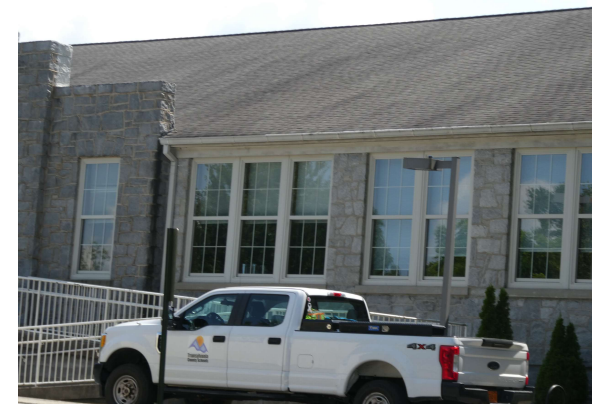
Stone face exterior and vinyl hung windows.

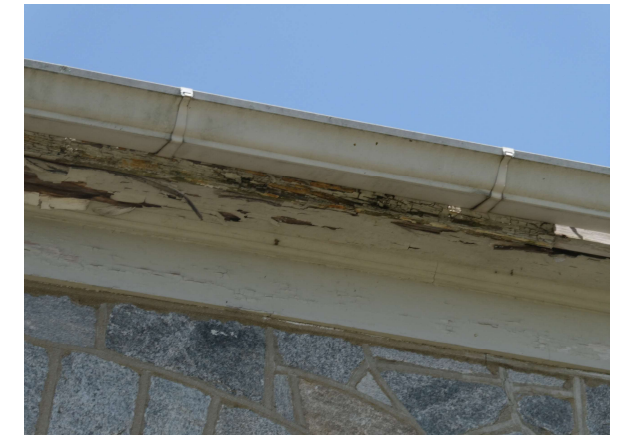
Damaged wood soffit under roof.

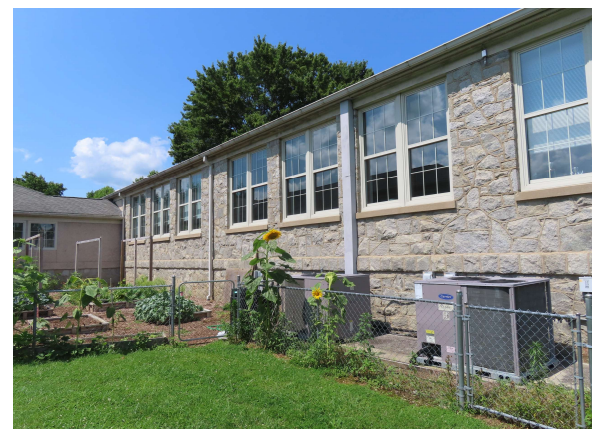
Stone faced walls and double pane aluminum and vinyl windows.

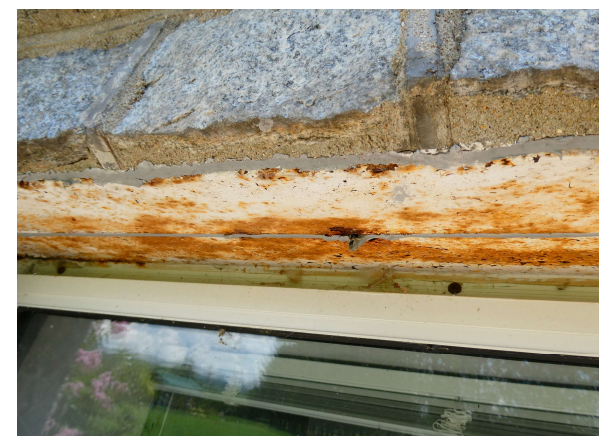
Corroded lintel at exterior windows.

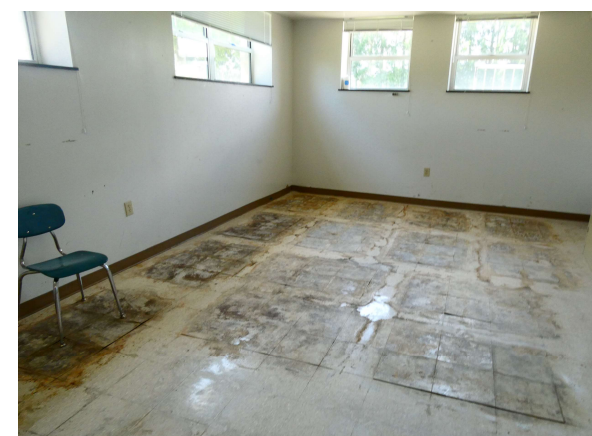
Deteriorated VCT flooring in basement floor.

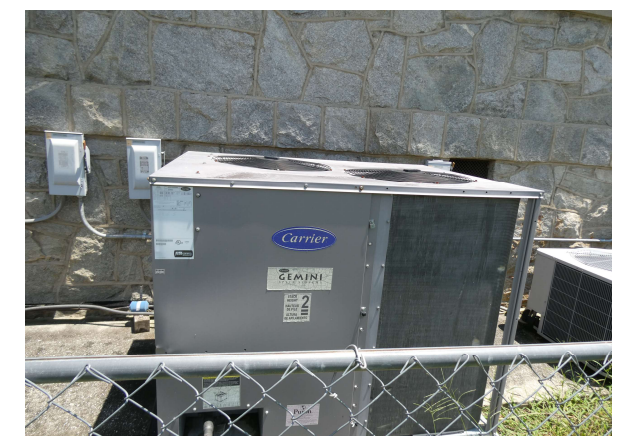
Split system air conditioning unit from 2013.
