REPORT OF FACILITY CONDITION ASSESSMENT

Morris Education Center

Property Address:
225 Rosenwald Lane
Brevard, NC 28712

Prepared By:
Axias
Project No. GA23-017
February 26, 2024

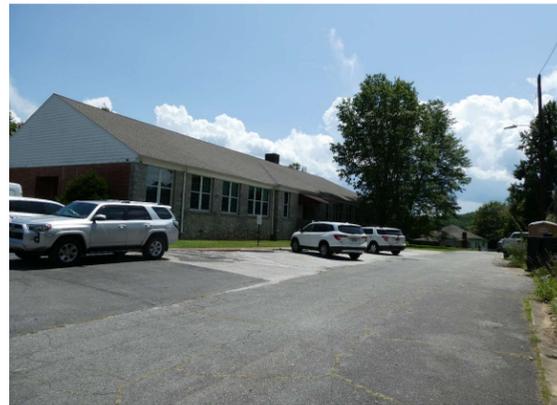
Asphalt parking lot and exterior elevations

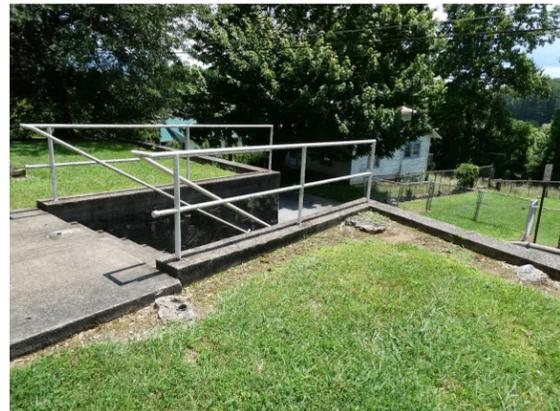
Missing handrails (right and left of steps) at change in level

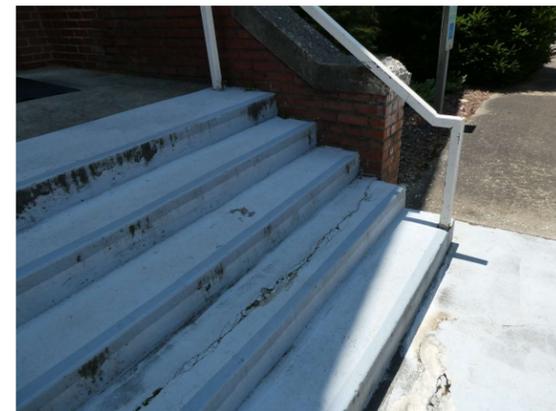
Damage to exterior steps at entrance

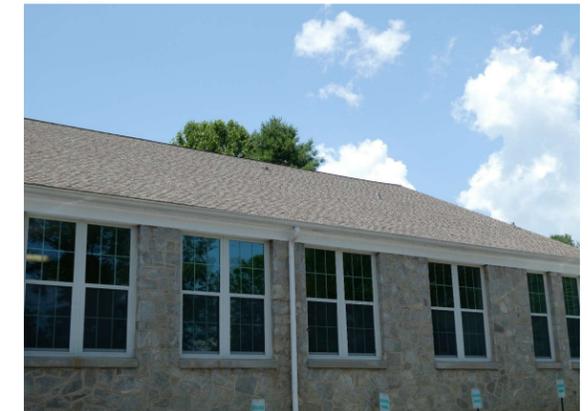
Overview of asphalt roof shingles

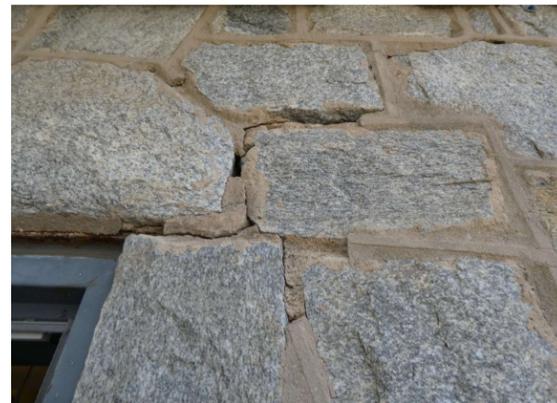
Cracking and deterioration to mortar joints

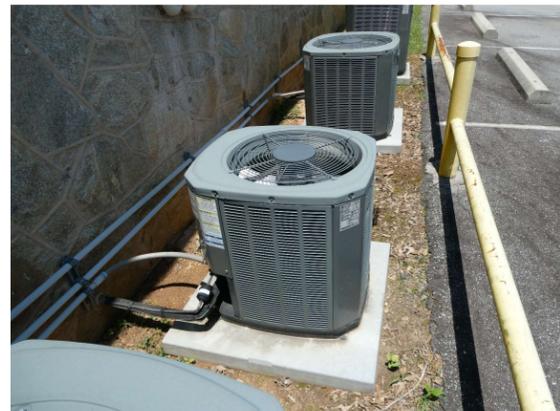
Exterior condensing units mounted at grade

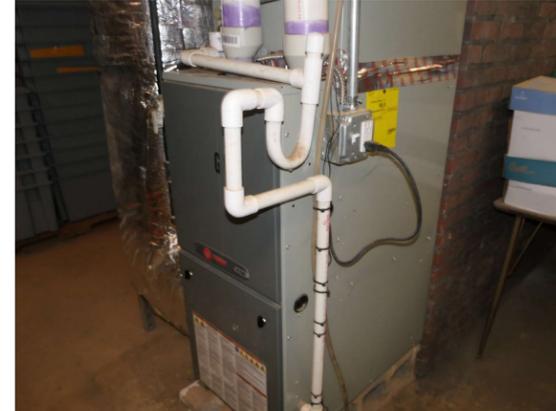
Furnace with in basement area

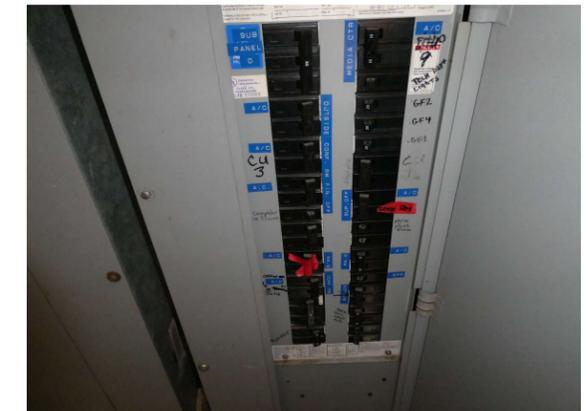
Electrical panelboard in basement area

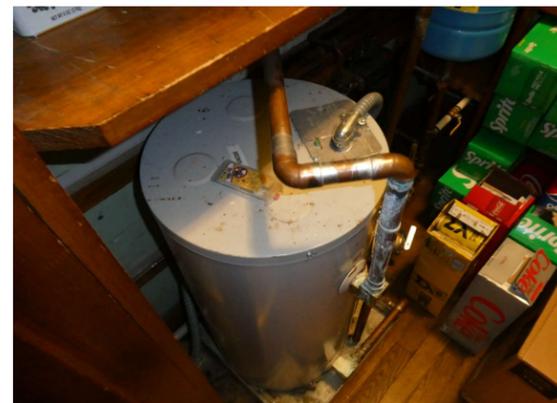
Domestic water heater in closet space

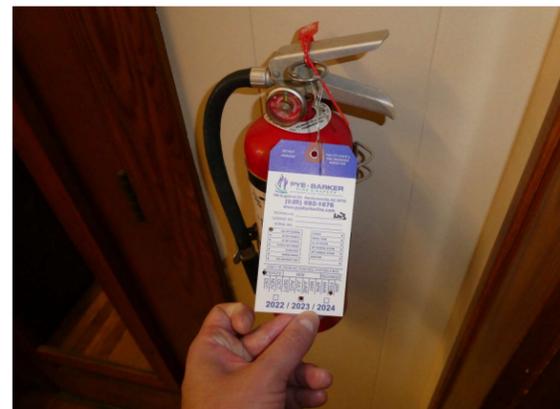
Handheld fire extinguisher

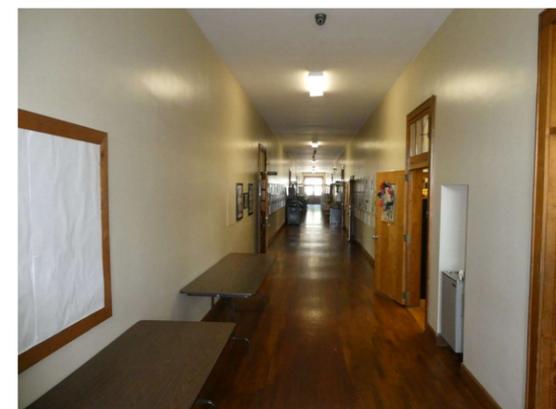
Typical interior finishes

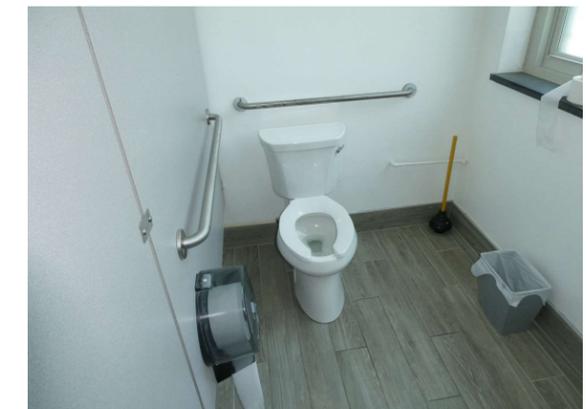
Bathroom with accessibility upgrades
