# Needs-Based Public School Capital Fund

## 2024-25 Grant Application

Brevard High School Construction and Repair

# FACILITY CONDITION ASSESSMENT SUMMARY REPORT

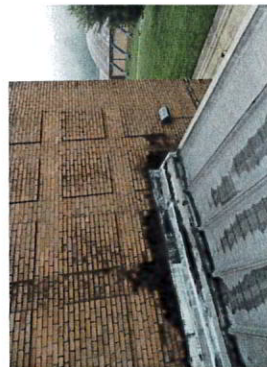
Area of water ingress at Auditorium

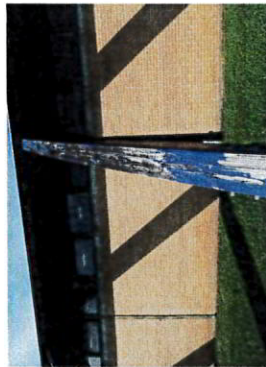
Deteriorated paint finishes at glulam beams at Old Gym

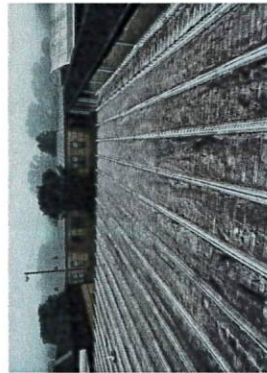
Original standing seam metal roofs

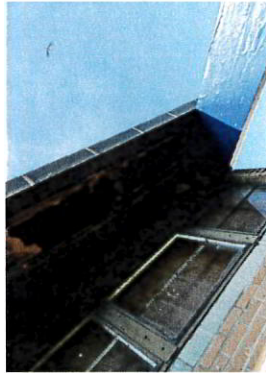
Failed and missing roof deck at Old Gym

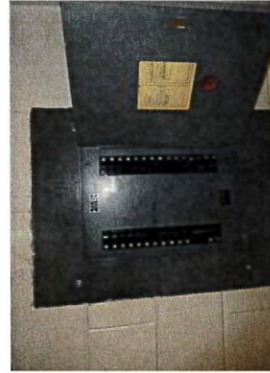
Older electrical equipment

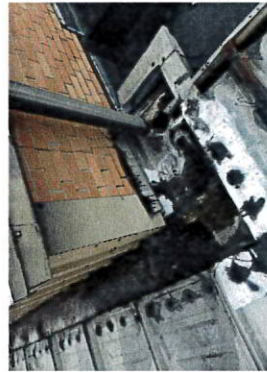
Poor drainage detailing and area of persistent water ingress

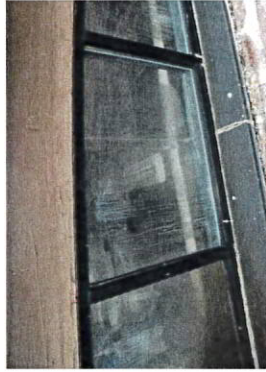
Fogged glazing at Cafeteria roof

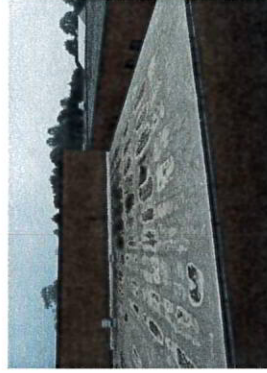
Roof covering at EC Wing in poor condition

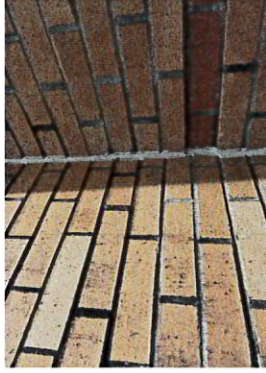
Sealant joints in brickwork in poor condition

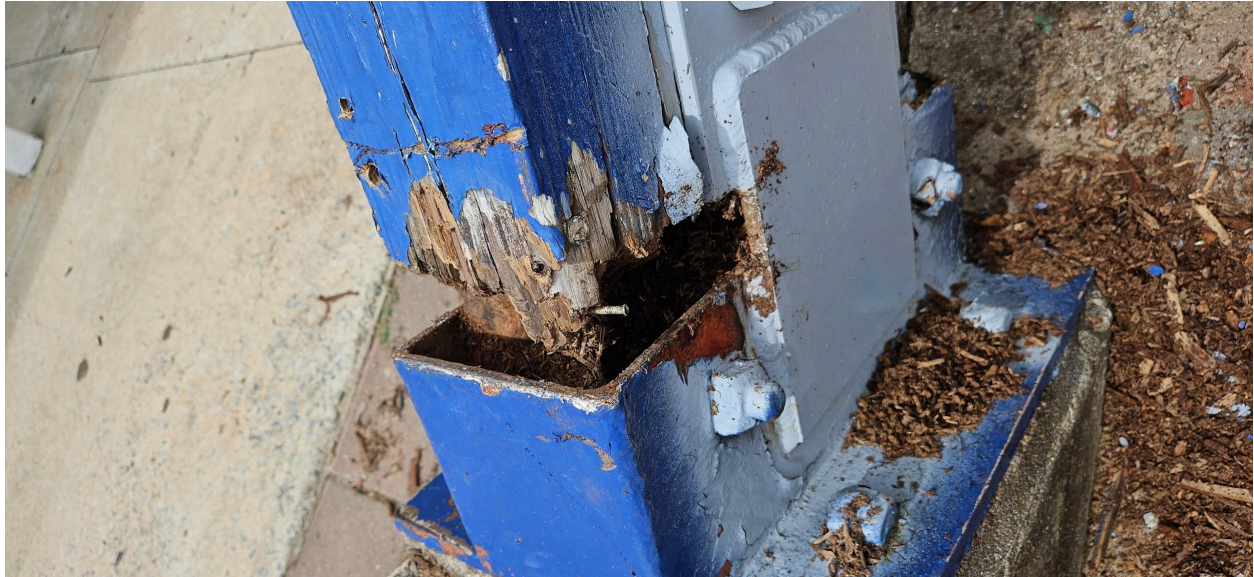
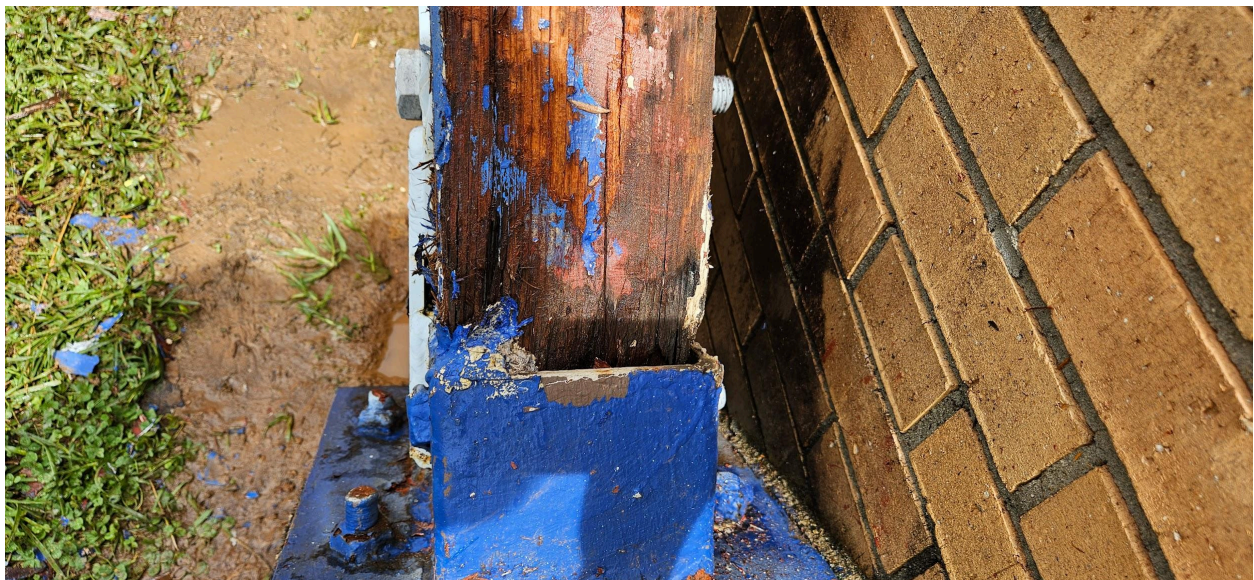
**Artifact 1**

These pictures show one beam in the cafeteria building. Currently, the engineers suggest adding epoxy and enclosing it in metal. After this repair, the engineers said to inspect every two years; the life span can be five years. See Attachment E document from the engineers.

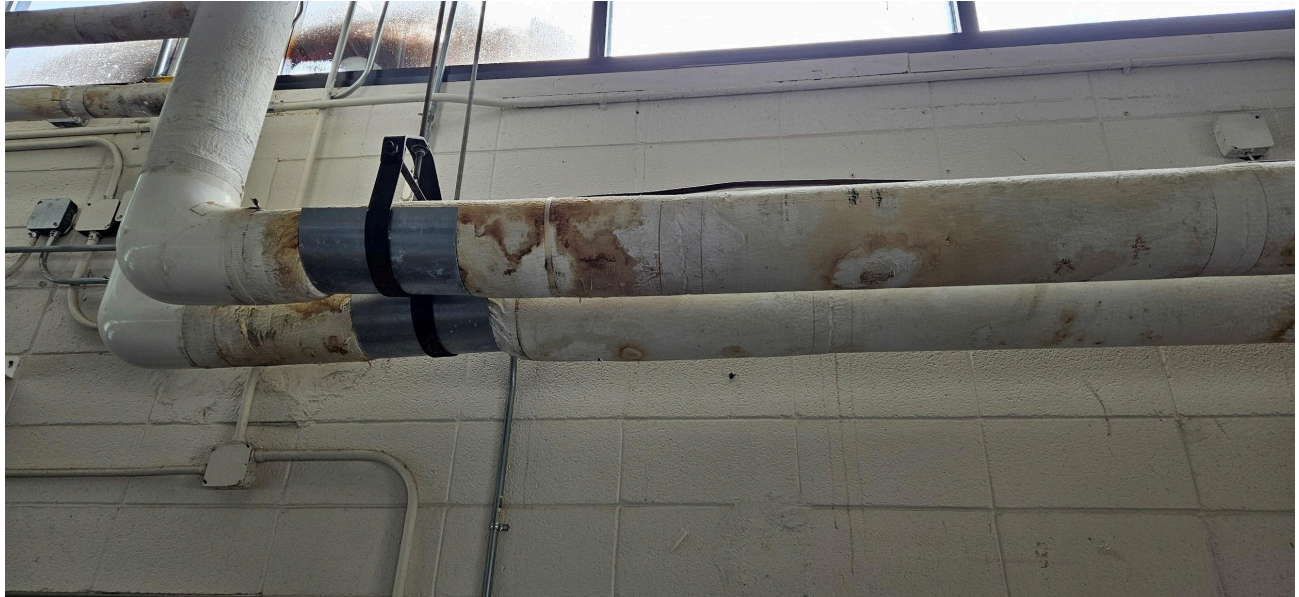
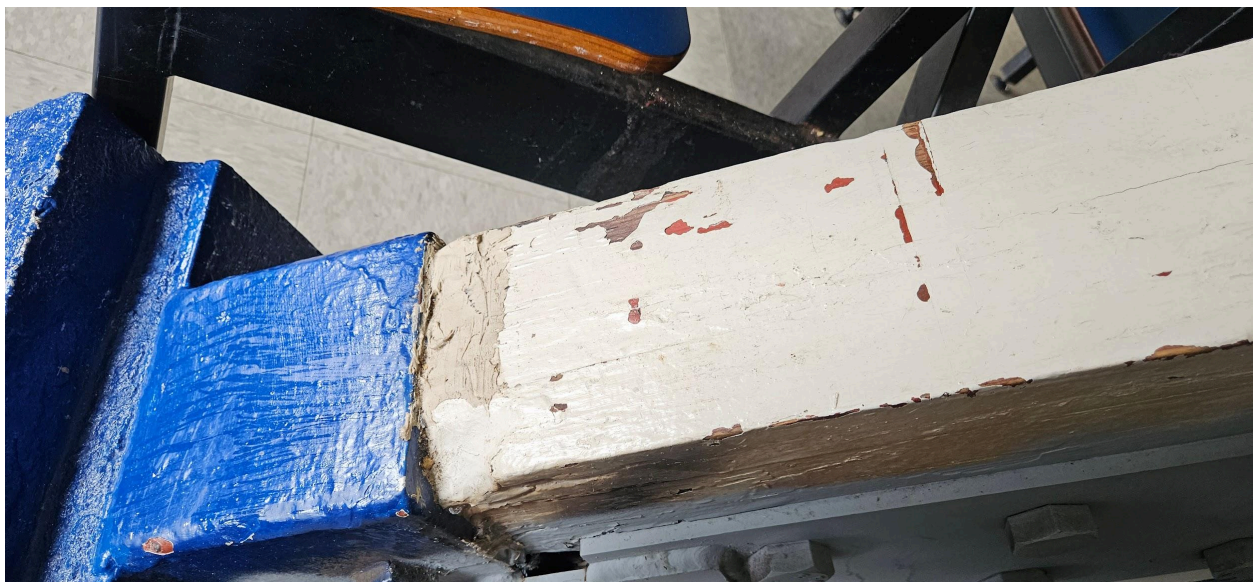
**Artifact 2**

These pictures represent the inside of the cafeteria. One photo shows an old two-pipe HVAC system, and the other shows a beam located within the cafeteria. Please note that the beam has already been repaired without outside weather conditions affecting its life.

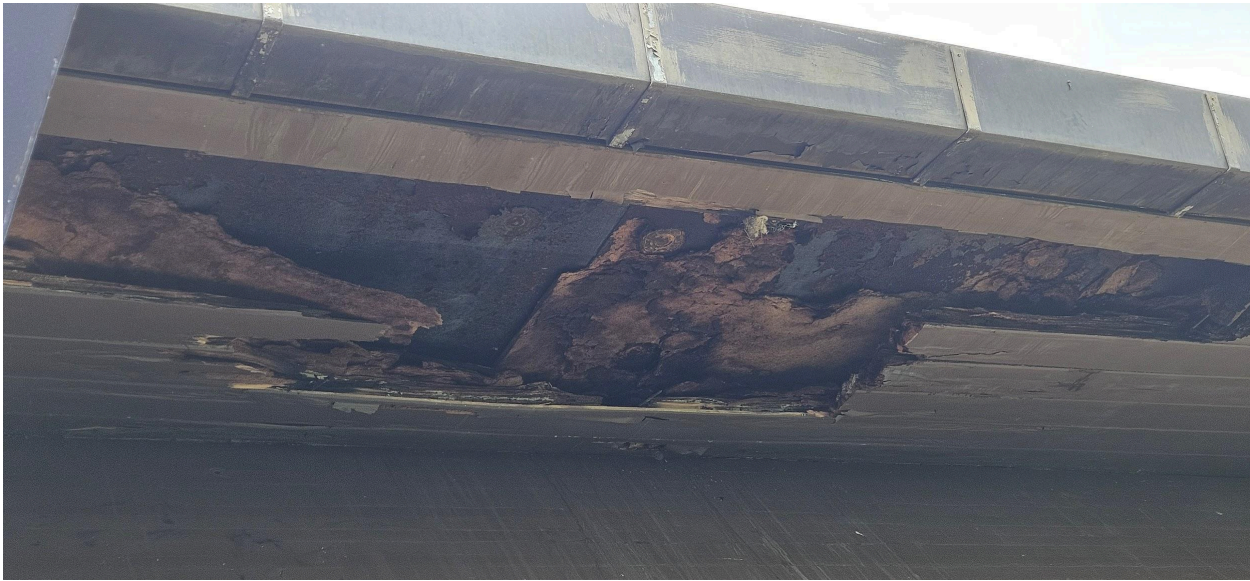
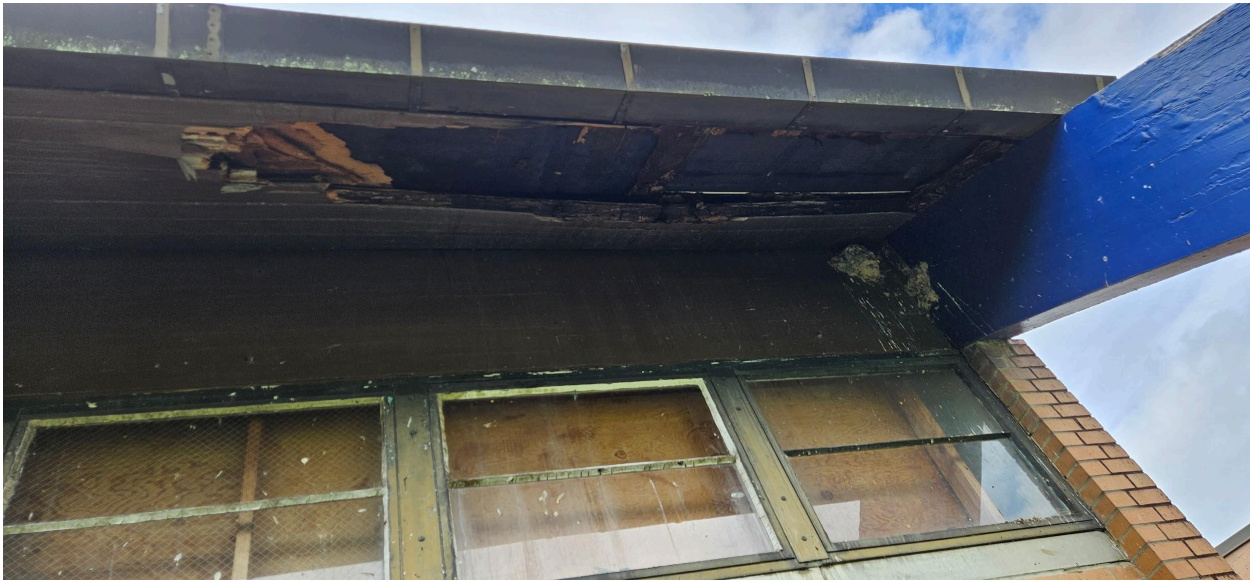
**Artifact 3**

These pictures represent the eaves on the 1949 gym building.

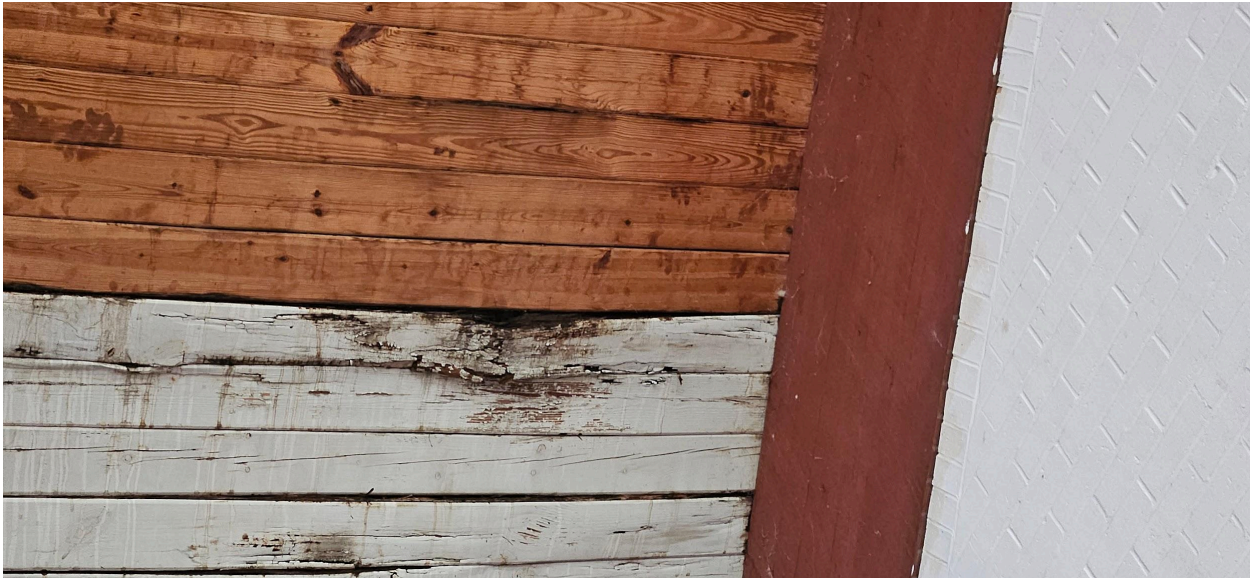
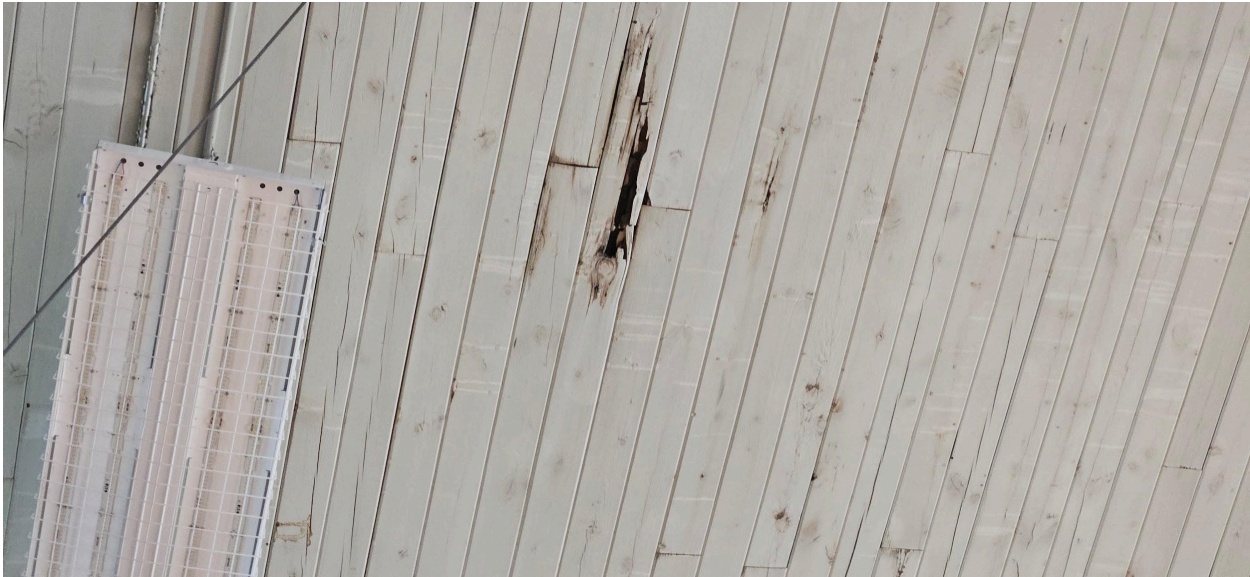
**Artifact 4**

These pictures represent just some of the ceiling rot that has occurred from the roof leaks.

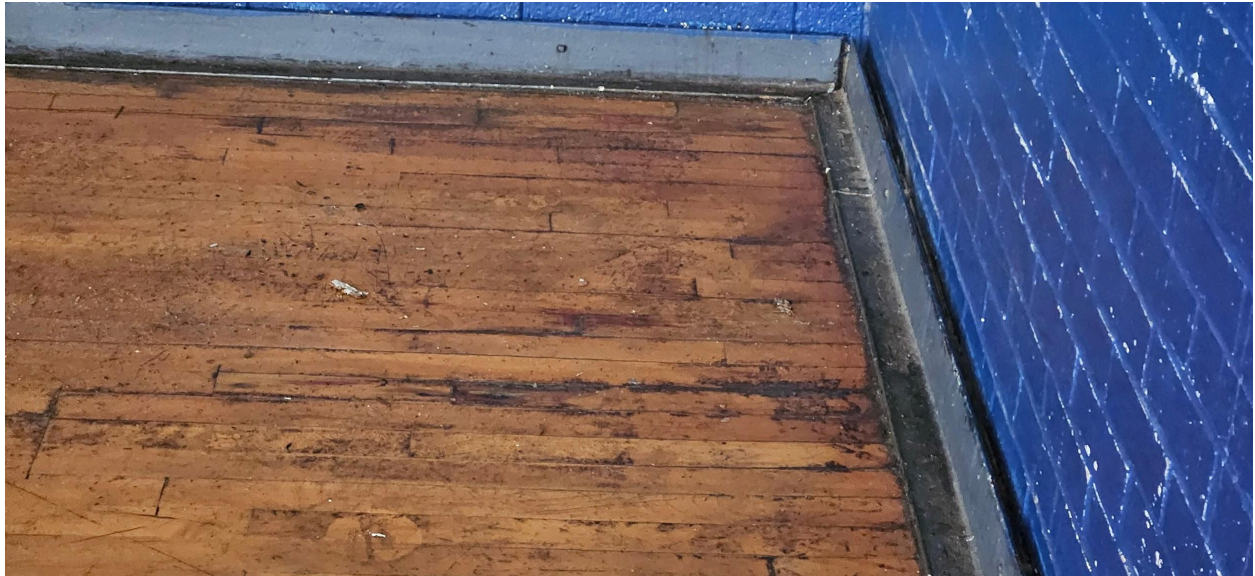
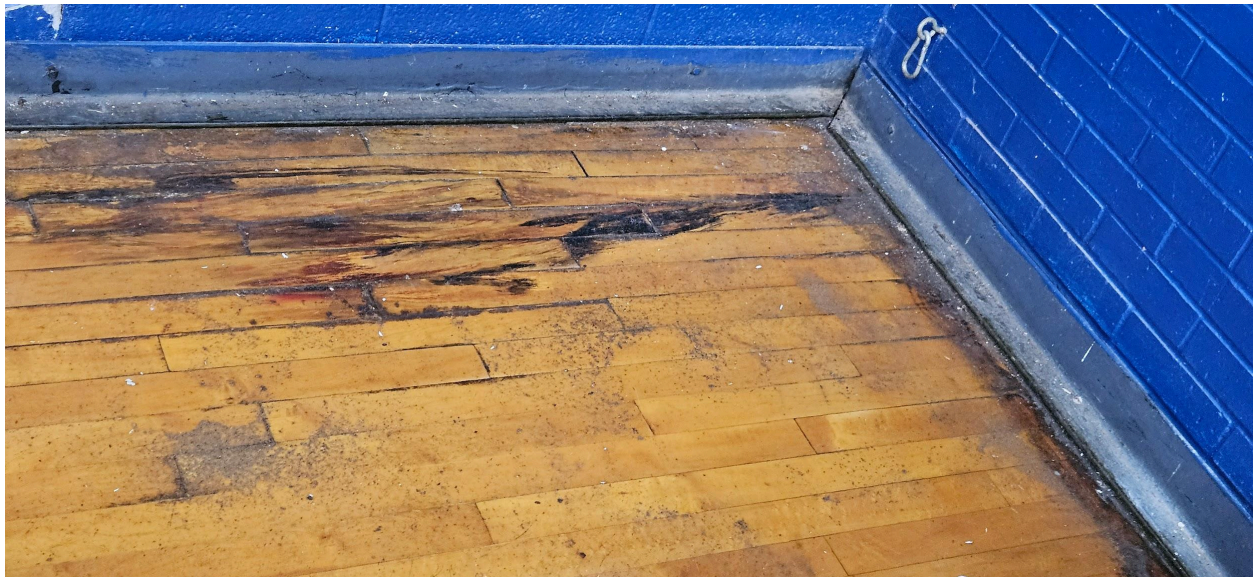
**Artifact 5**

These pictures represent the damage to the gym floor from the roof/ceiling leaks.

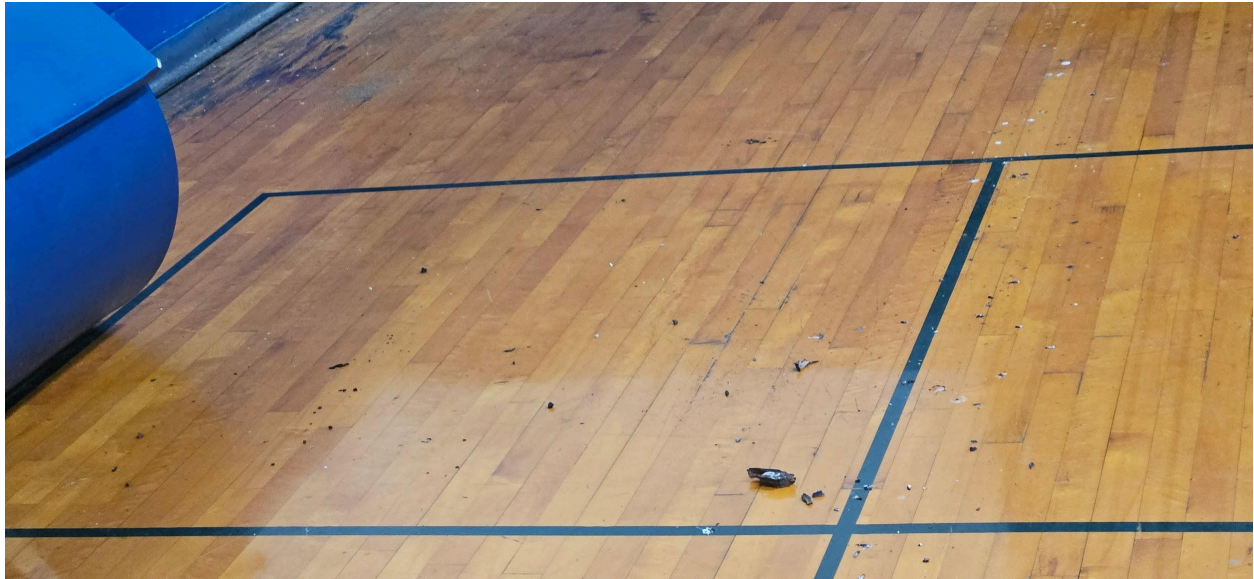
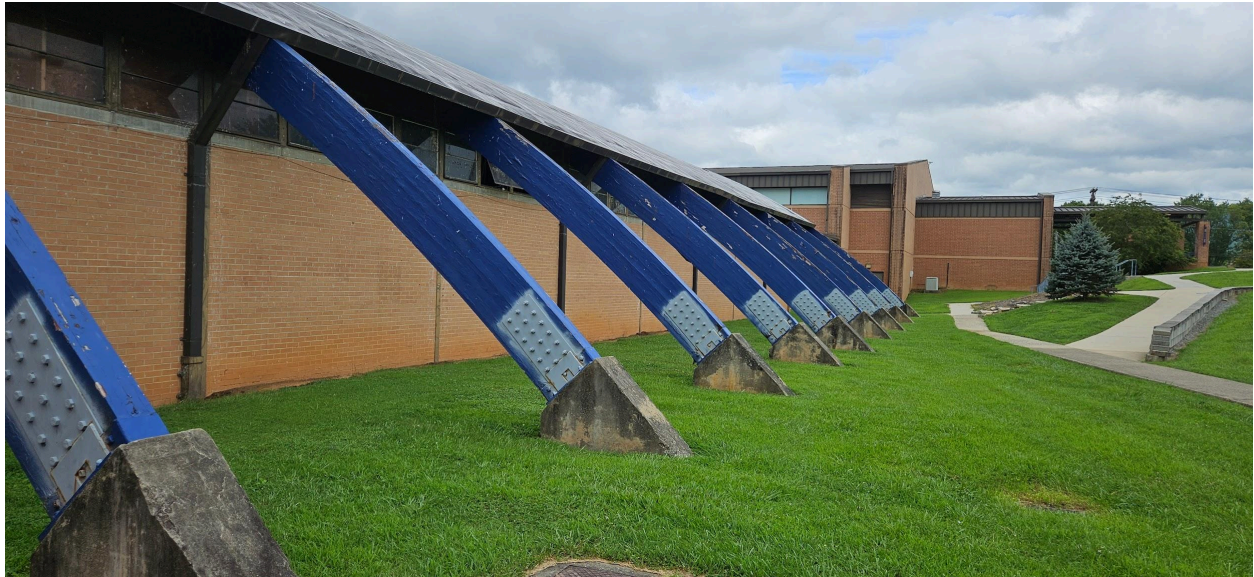
**Artifact 6**

One picture shows how, after a hard rain, parts of the ceiling fall onto the gym floor. The other picture shows how the beams support the building. This particular picture is of one side of the gym.

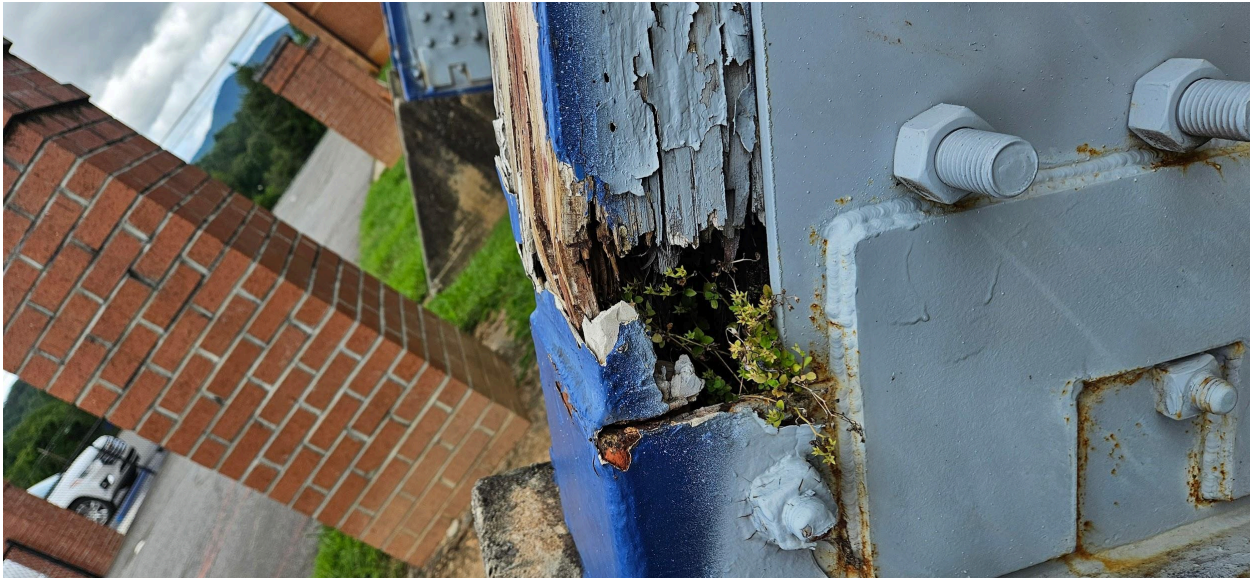
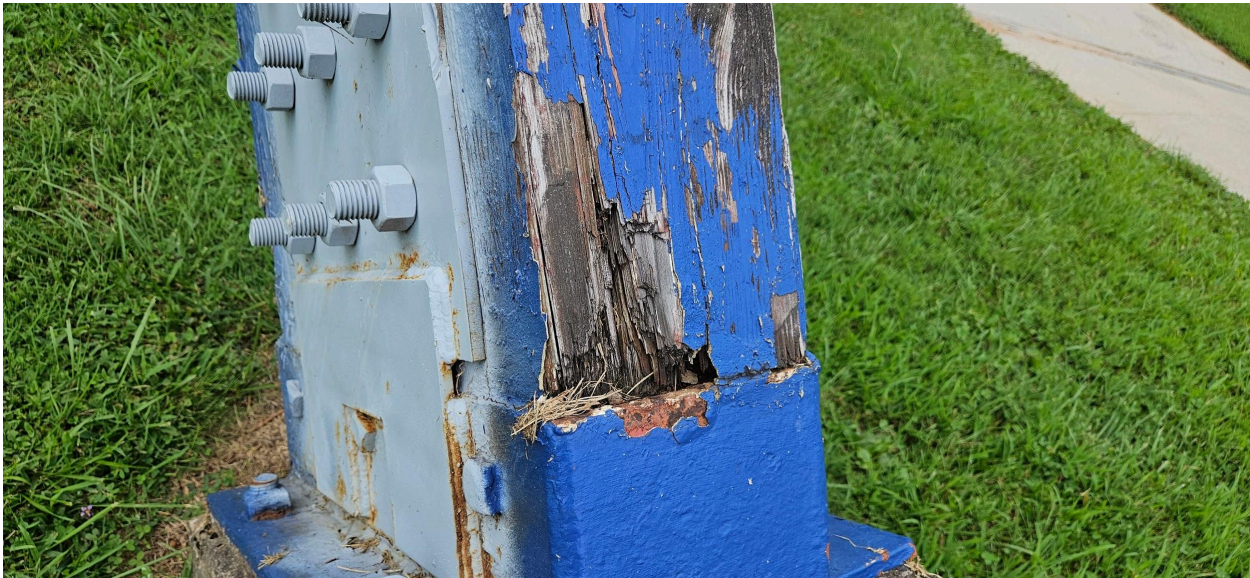
Artifact 7

These pictures represent the beams that are located on the gym.
