REPORT OF FACILITY CONDITION ASSESSMENT

Pisgah Forest Elementary School

Property Address:
1160 Ecusta Road
Brevard, NC 28712

Prepared By:
Axias
Project No. GA23-017
February 26, 2024

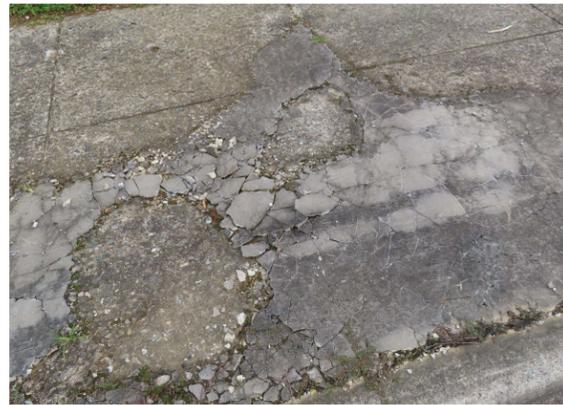
Typical concrete sidewalk deterioration

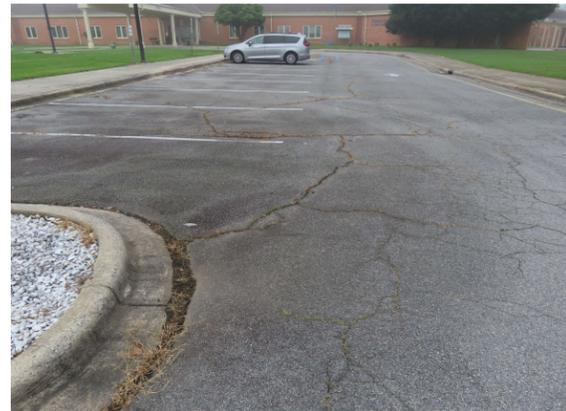
Asphalt parking lot with surface deterioration

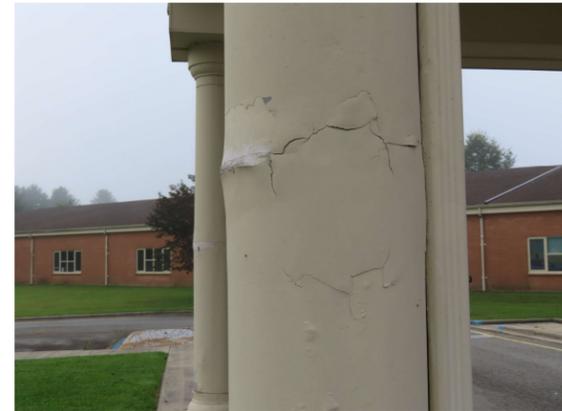
Damaged column at entrance

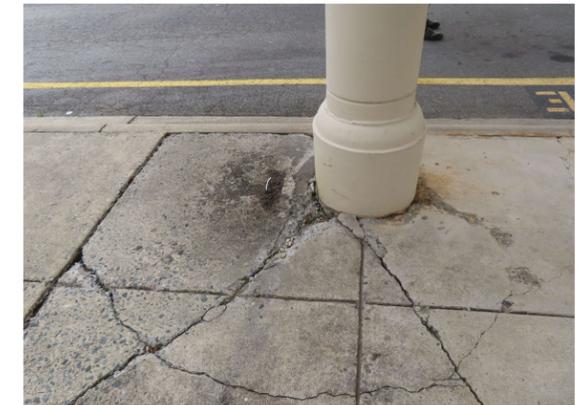
Typical concrete panel sidewalk damage extending around column

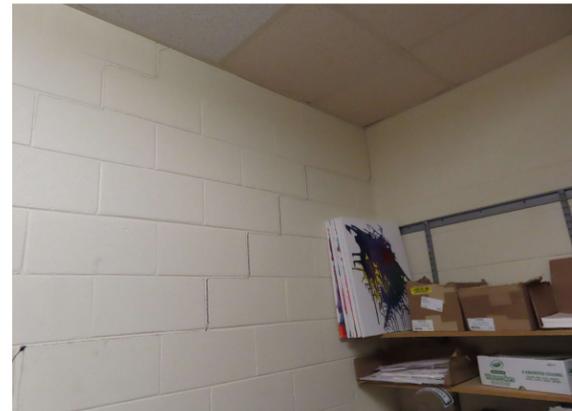
Stairstep cracking on interior painted CMU

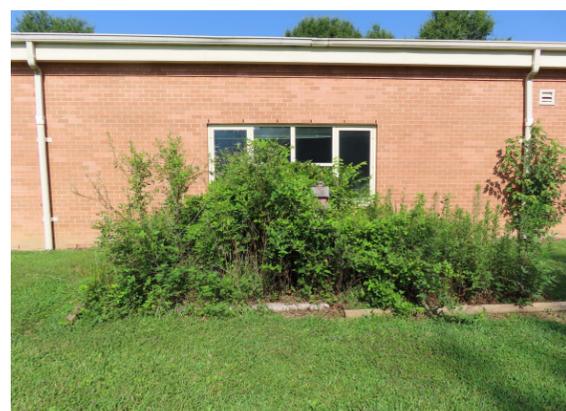
Exterior window view with one of the classrooms' moisture

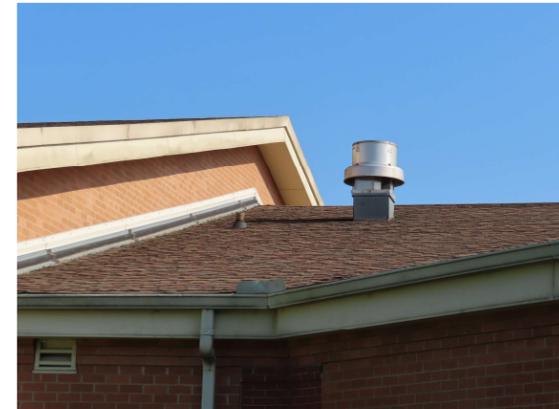
Asphalt shingle roof and aluminum gutters

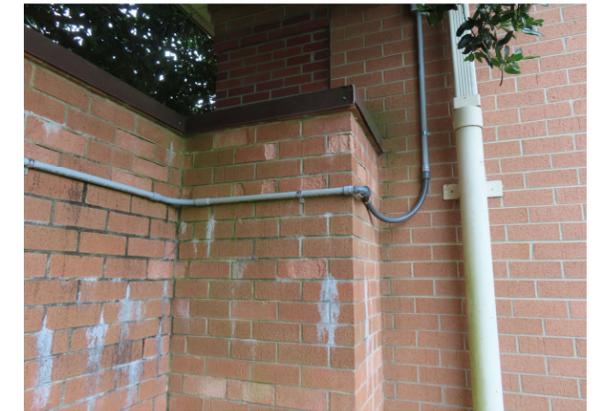
Exterior brick masonry with deteriorated sealants and spalled brick

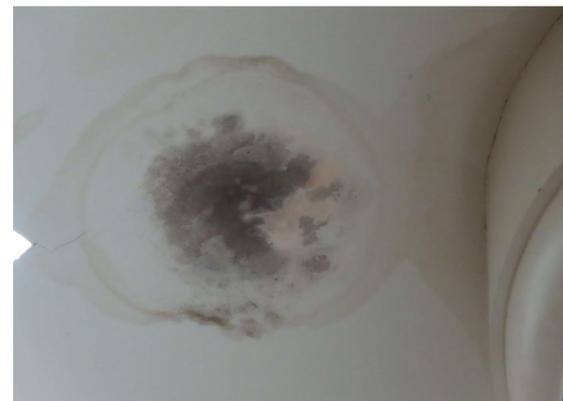
Staining from moisture in ceiling in front of the media center

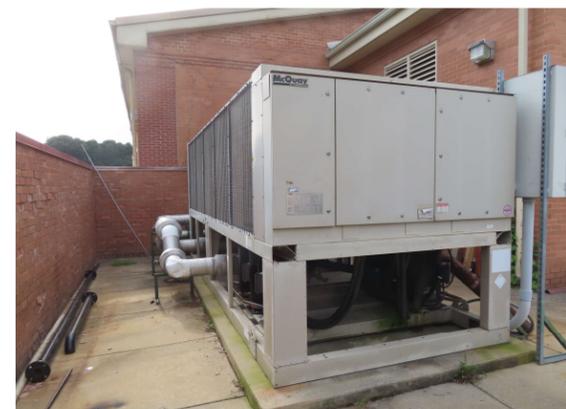
Air-cooled chiller by McQuay

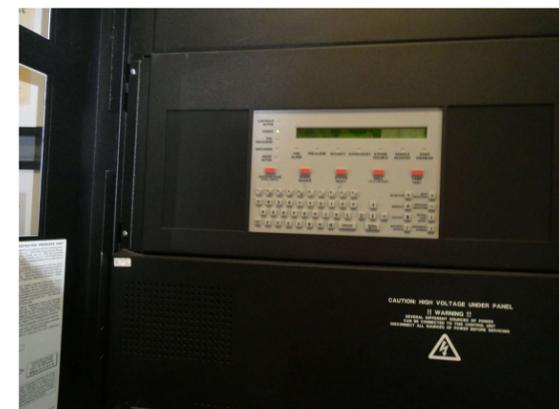
Fire detection and alarm system by Notifier

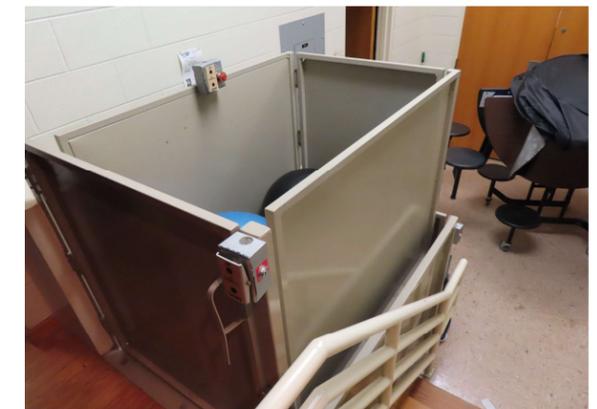
Platform elevator lift in gymnasium/ theatre
