REPORT OF FACILITY CONDITION ASSESSMENT

PLANT OPERATIONS

Project No. GA23-017

February 26, 2024

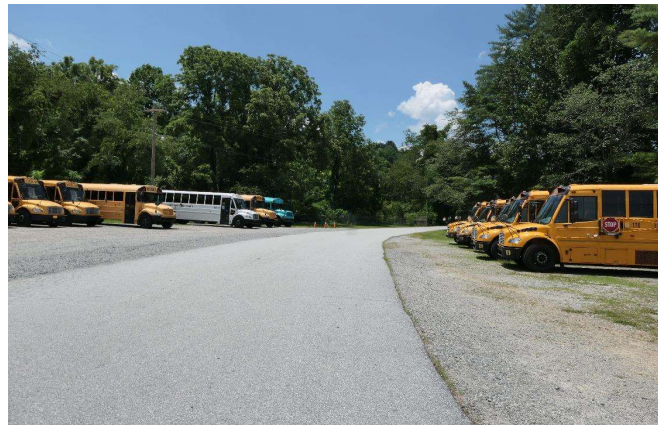
Access road and paved areas

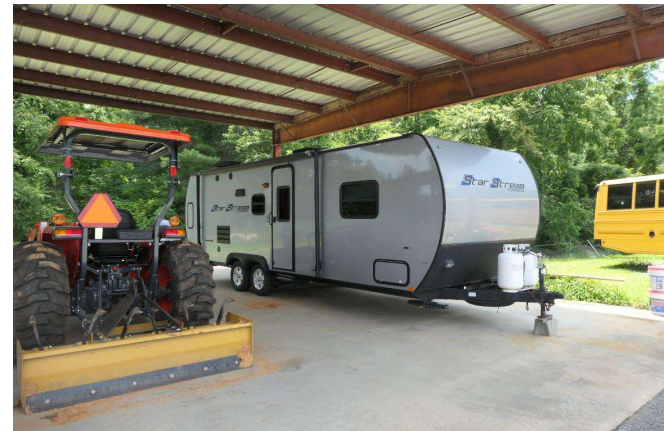
Covered vehicle structure

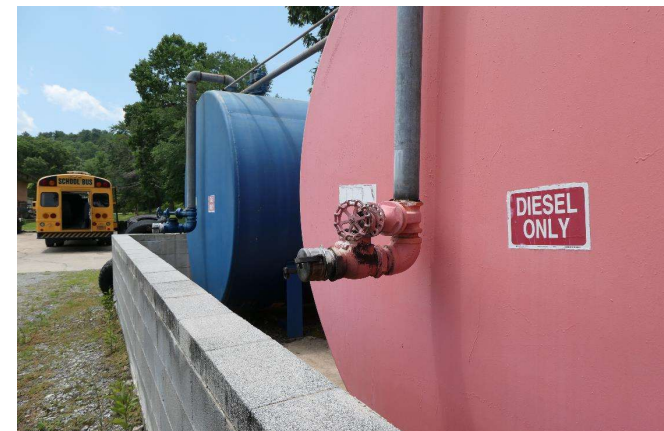
Fuel storage tanks

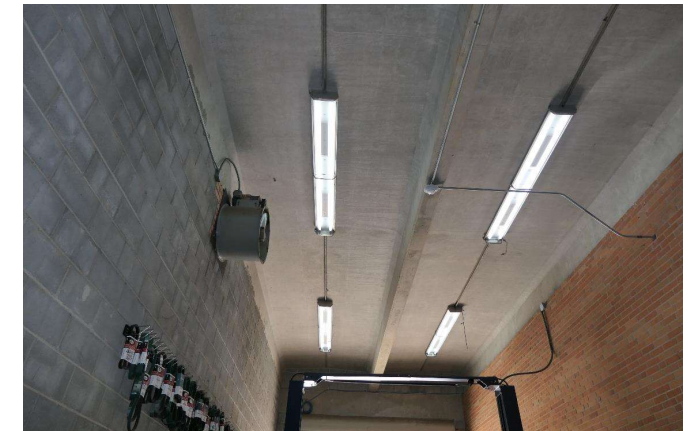
Interior ceiling at vehicle repair bay

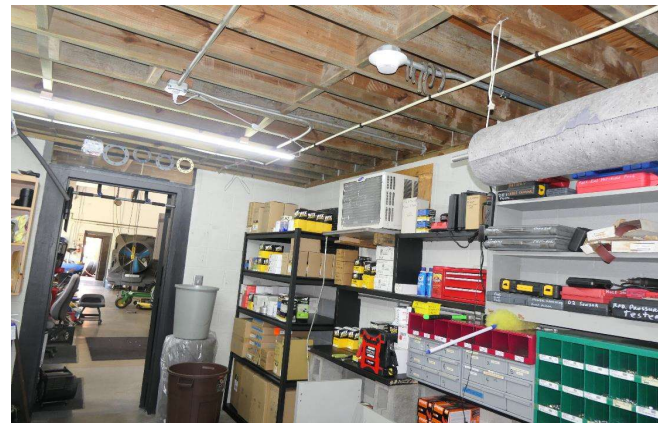
Interiors of vehicle repair bay

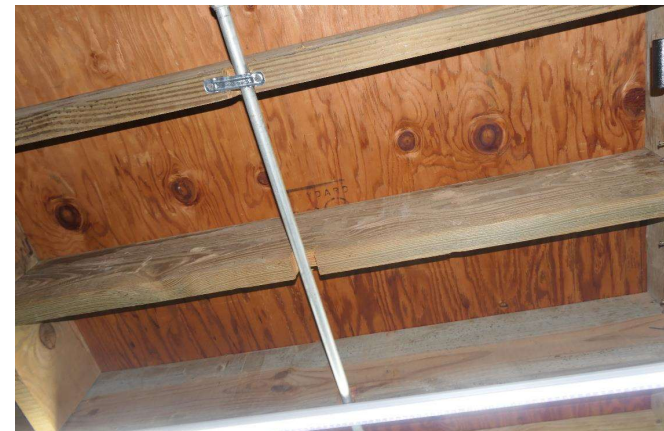
Typical wood decking for mezzanine storage

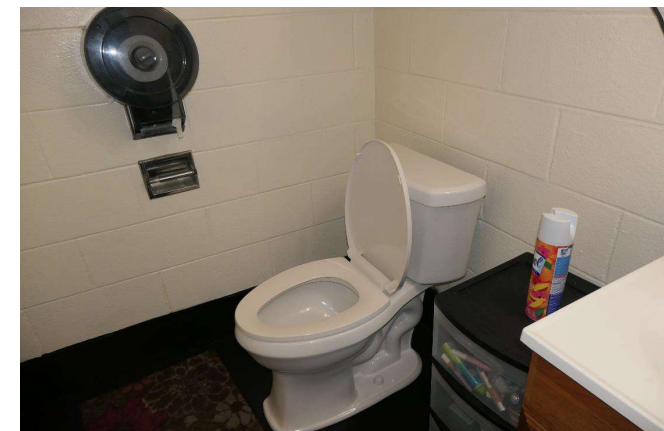
Interior bathroom finishes

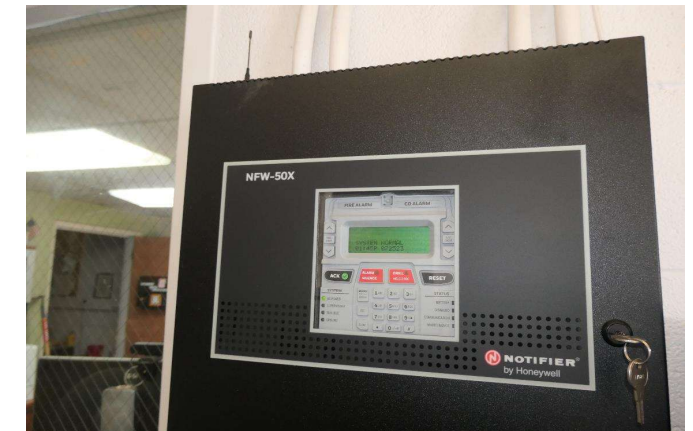
Fire alarm control panel

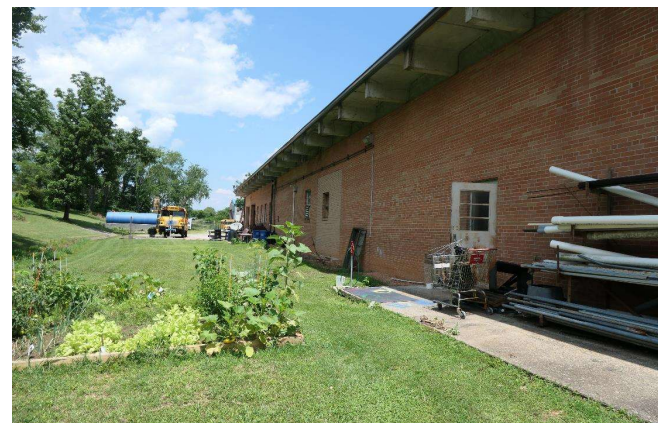
Building exteriors

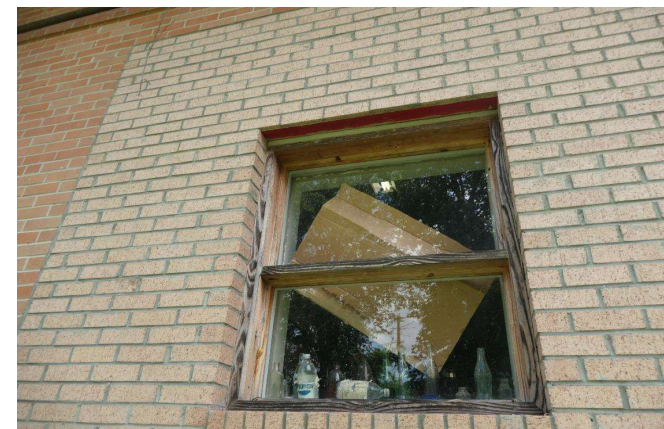
Exterior wall and window systems

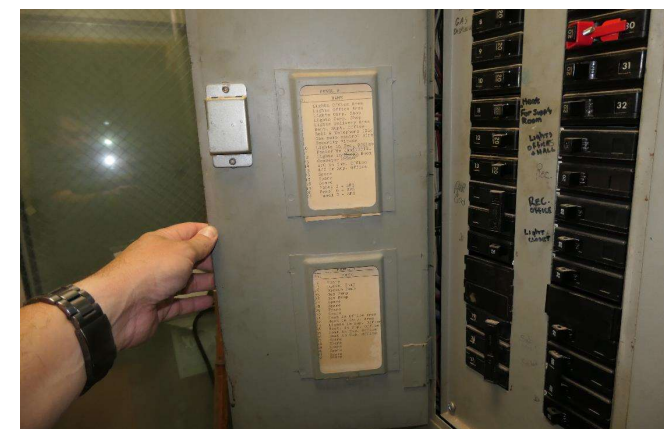
Typical panelboard

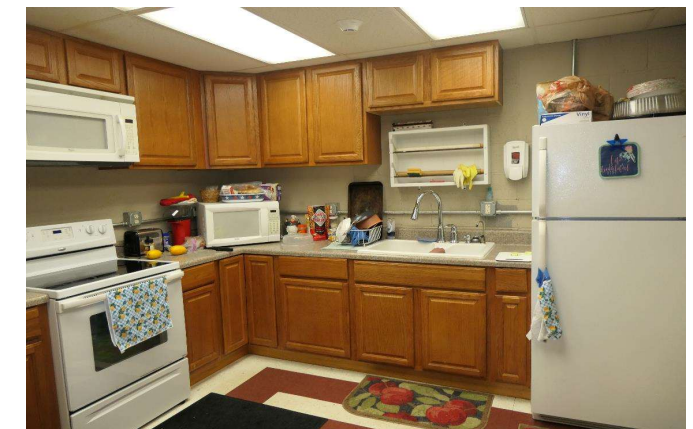
Break room/rest area
