# REPORT OF FACILITY CONDITION ASSESSMENT

## Rosman Elementary

167 Rosman School Rd  
Rosman, NC 28772

Project No. GA23-017

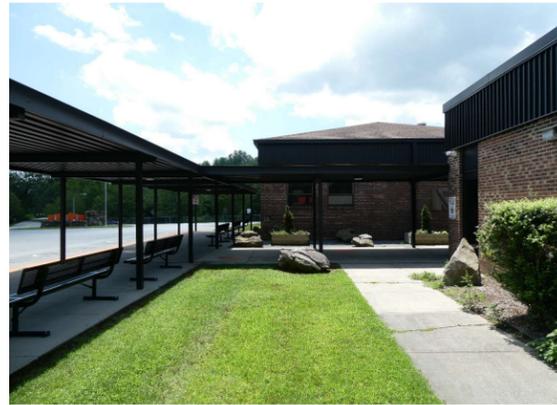
Exterior walkway and sidewalk/path areas

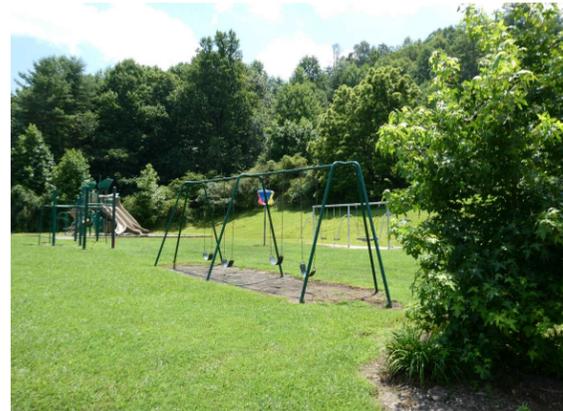
Exterior site features

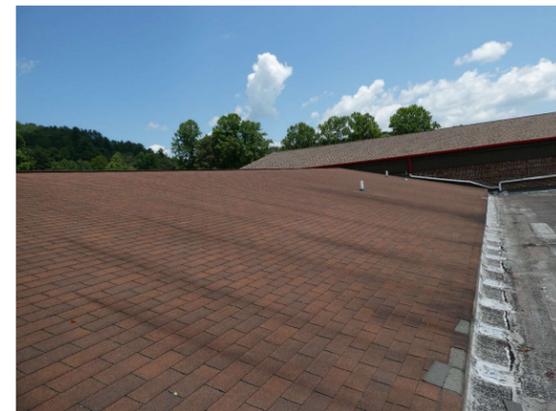
Deteriorating asphalt shingle roof covering

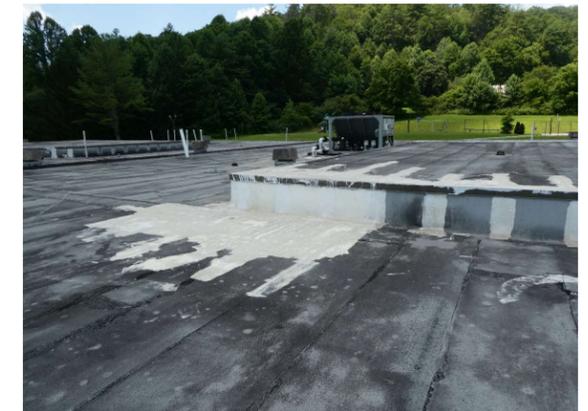
Previous repairs to modified bitumen roof

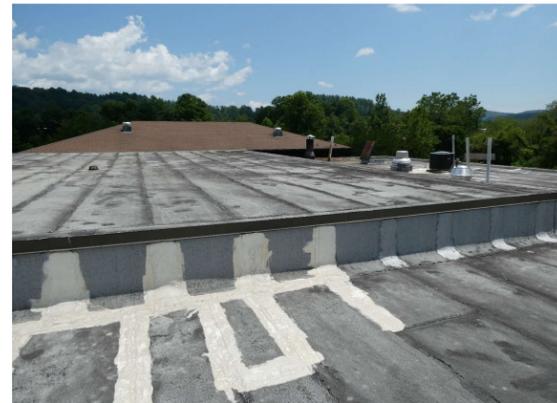
Deteriorated modified bitumen roof and previous repairs

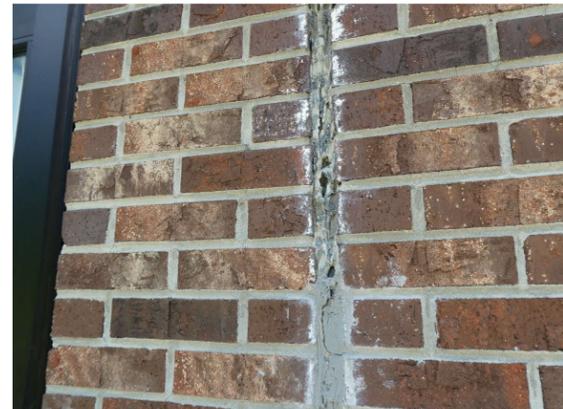
<b>Exterior Elements Required</b>																										
1	Exterior movement joints within the brickwork are filled with elastomeric sealant. Sealant joints across the building were in poor condition and were cracked and have dried out.	Replace exterior sealant joints.	III	DM	4	3	3	4	14	Medium	10	1	1,400	LF	\$10	\$14,000										\$14,000
2	Exterior windows and doors are set within exterior masonry walls. At the perimeters of the metal frames and the brickwork, a perimeter bead of elastomeric sealant is installed. Sealant joints were in a fair condition, but are expected to need replacement in the mid-term of the study.	Replace perimeter window sealant joints.	III	SM	4	4	4	5	17	Low	10	5	1,850	LF	\$10					\$18,500						\$18,500
3	The metal canopy structure was in a good condition and the majority of the supporting structure appeared to have been recently repainted. However the section at the south of the building was in poor condition and should be repainted as an operational expense. We anticipate that the metalwork will need to be repainted in the mid-term of the study.	Prepare metalwork to canopy walkway structure and repaint.	V	CR	5	4	4	5	18	Low	10	5	7,200	SF	\$8					\$57,600						\$57,600

Deteriorated movement joints in brickwork

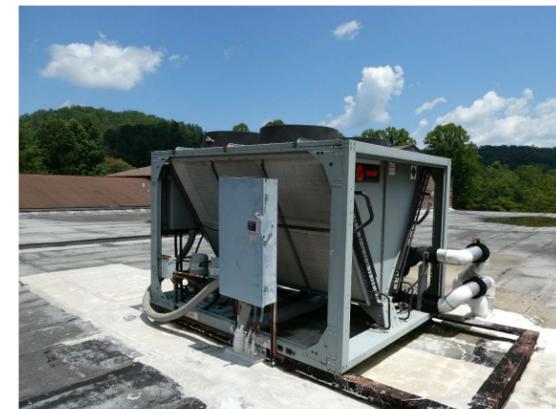
Air-cooled chiller installed on roof

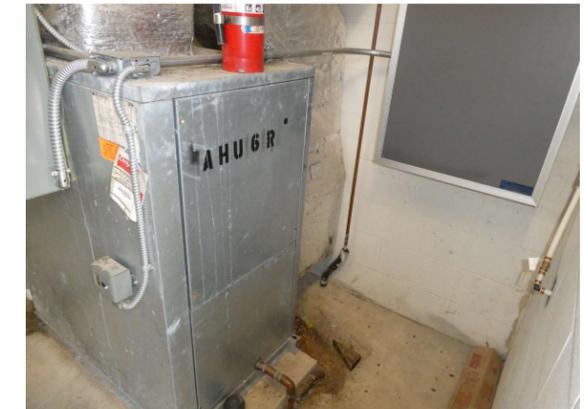
Air handler in mechanical room

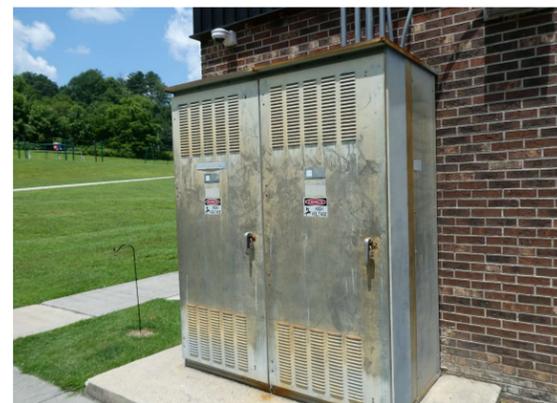
Aged electrical switchgear

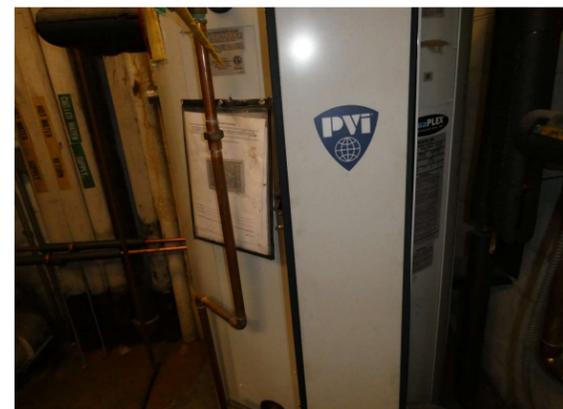
Commercial water heater

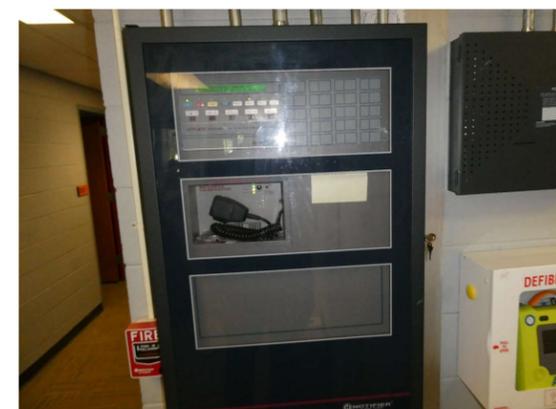
Fire alarm control panel

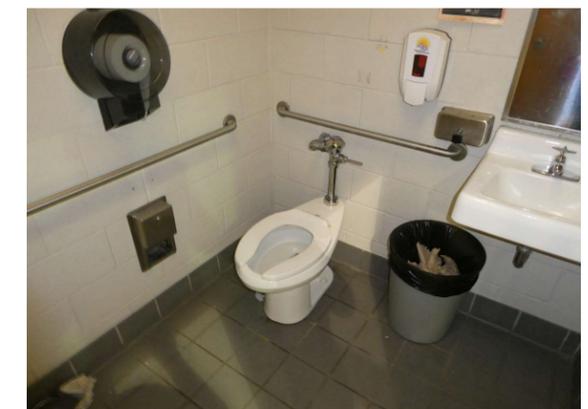
Restroom with partial accessibility upgrades
