# REPORT OF FACILITY CONDITION ASSESSMENT

## **Rosman Middle and High School**

*Property Address:*  
749 Pickens Hwy  
Rosman, NC 28772

*Prepared By:*  
Axias  
Project No. GA23-017  
February 26, 2024

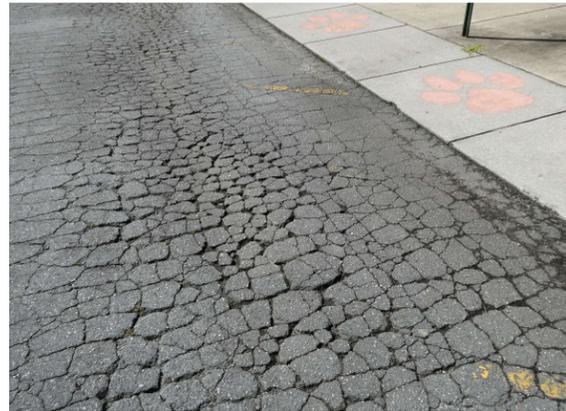
Deteriorated paving at rear of New Gym area

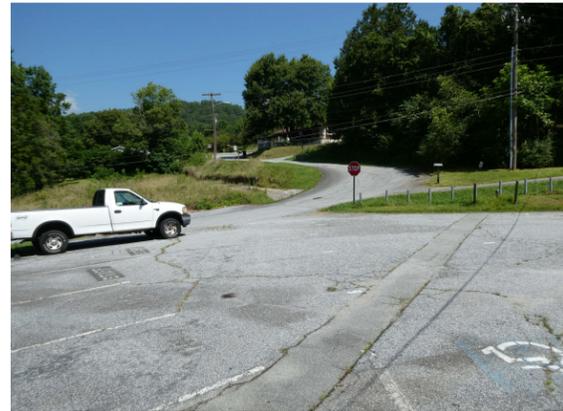
Cracked asphalt paving

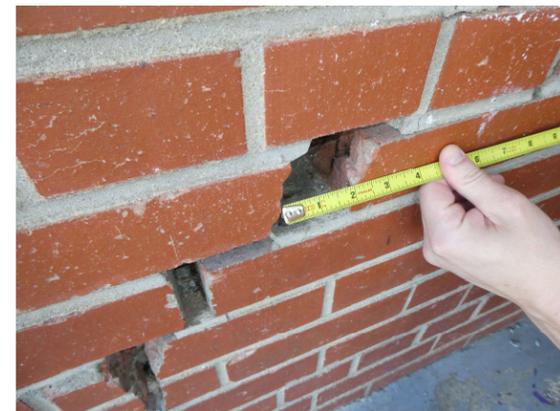
Structural cracking at Old Gym building

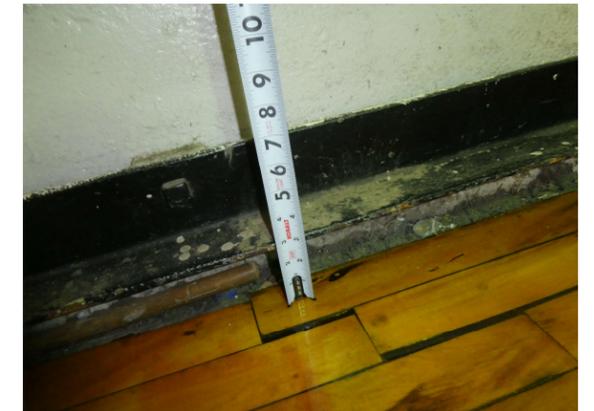
Structural movement at Old Gym building

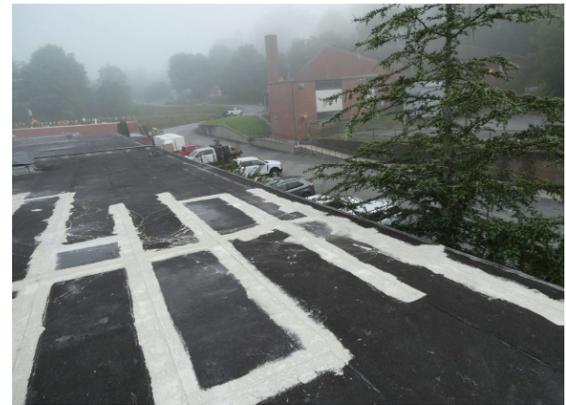
Deteriorated roof covering and former repairs

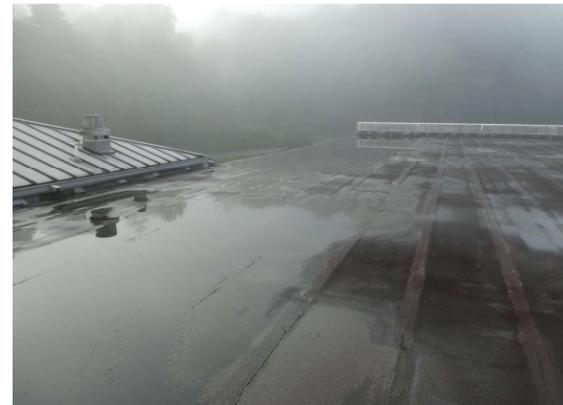
Standing water on roof

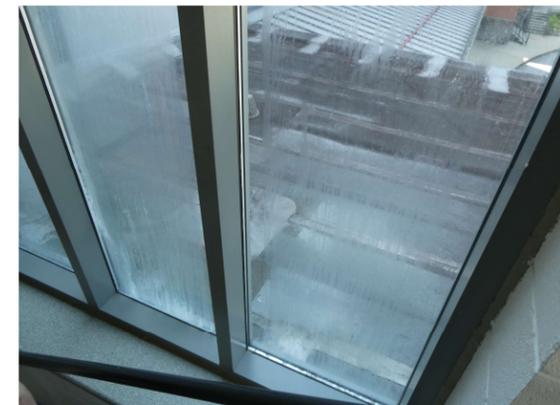
Fogged IGUs at bell tower

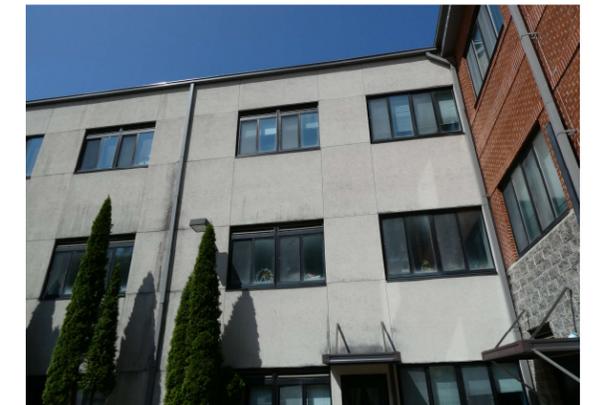
Stained/discolored EIFS

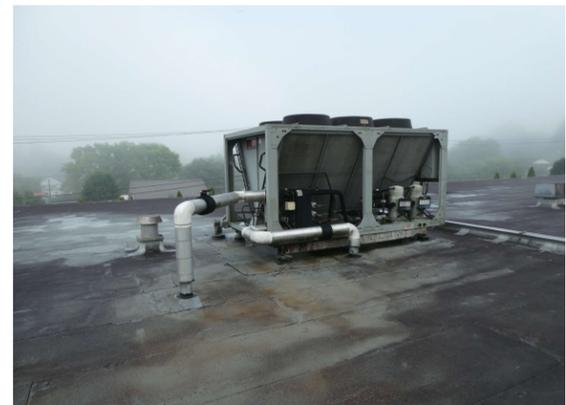
Rooftop chiller

<b>Mechanical Required</b>																										
1	The chiller located outside the Cafeteria is in fair condition. It has exceeded its recommended useful life and the site contact reported that it frequently requires repairs. Active alarms indicating cooling circuit failures were noted on the use interface control panel. The chiller serves a large portion of the building and should be replaced early in the term, before it becomes unreliable, or a complete failure occurs.	Replace air-cooled chiller outside the Cafeteria.	III	CR	2	3	3	3	11	High	25	1	110	TON	\$4,200	\$462,000										\$462,000
2	The chiller mounted on the roof serving the northern portion of the building was in fair to good condition. The chiller was manufactured by Trane in 2013. Based on a typical service life of 20 to 25 years, it is recommended to budget for the replacement of the chiller during the study period.	Replace rooftop chiller serving the north end of the building.	IV	CR	3	4	4	5	16	Medium	20	9	60	TON	\$4,200									\$252,000	\$252,000
