REPORT OF FACILITY CONDITION ASSESSMENT

TC Henderson Elementary

11839 Rosman Hwy
Lake Toxaway, NC 28747

Axias
Project No. GA23-017
February 26, 2024

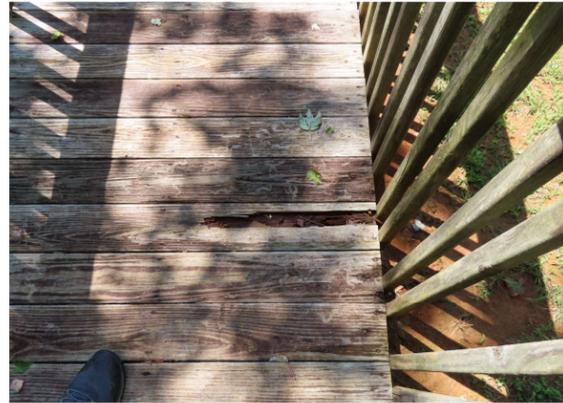
Wooden bridge walkway towards lower play area with some deterioration.

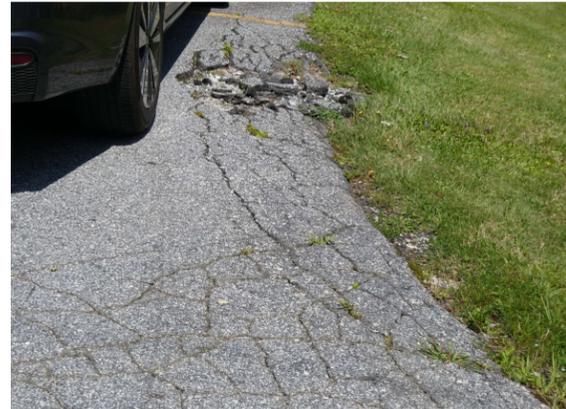
Damaged asphalt in front of school.

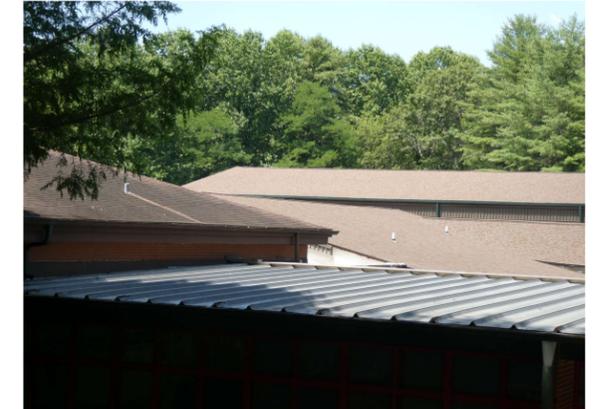
Overview of corrugated metal pitch roof and asphalt shingle roof

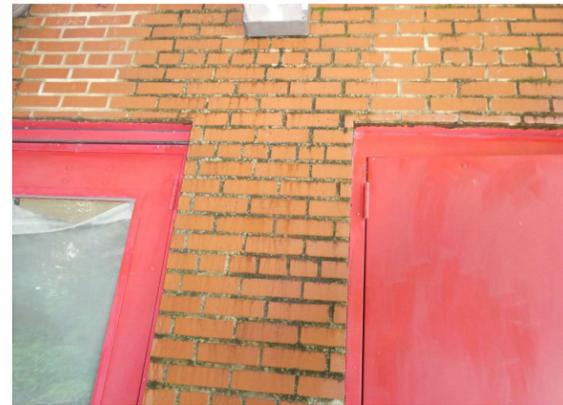
Exterior brick façade with aluminum framed doors and windows along with surface staining.

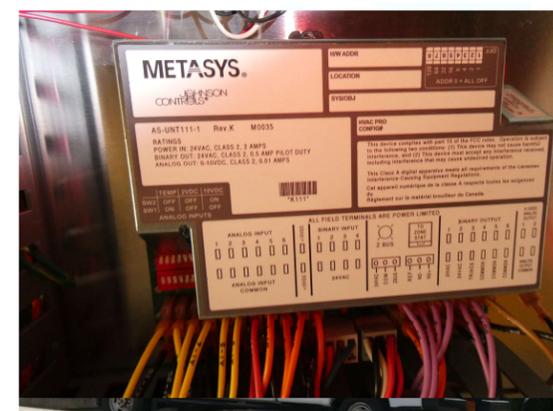
Obsolete Johnson Controls HVAC controller.

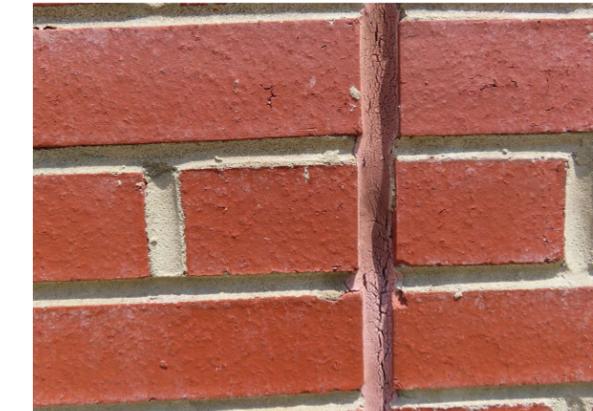
Typical condition of exterior sealants.

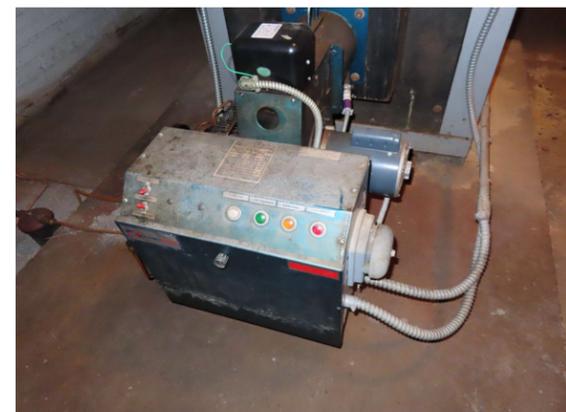
Mechanical Required																											
1	Heating hot water is provided by a Peerless 1,077-MBH oil fired boiler installed in 2000. This system appeared to be in fair condition, but replacement based on age is expected.	Replace heating hot water boiler.	III	CR	4	4	4	4	16	Medium	25	5	1,077	MBH	\$110					\$118,470						\$118,470	
2	Air conditioning is provided by a combination of split system units, package units, and air handling units with chilled and hot water coils. Two of the split systems were manufactured by McQuay in 2000 with a rated capacity of 10-tons. An additional 2-ton split system was also noted on site. Based on the age of the split systems, it is recommended to budget for the replacement of the condensing units and interior fan coil units.	Replace 10-ton McQuay and 2-ton split systems.	III	CR	3	3	4	4	14	Medium	20	1	22	TON	\$3,750	\$82,500										\$82,500	
3	Air conditioning is provided by a combination of split system units, package units, and air handling units with chilled and hot water coils. One of the split systems was manufactured by International Comfort System in 1999 with a rated capacity of 5-tons. Based on the age of the split system, it is recommended to budget for the replacement of the condensing unit and interior fan coil unit.	Replace 5-ton ICS split system.	III	CR	3	3	4	4	14	Medium	20	1	5	TON	\$3,750	\$18,750										\$18,750

Peerless boiler unit.

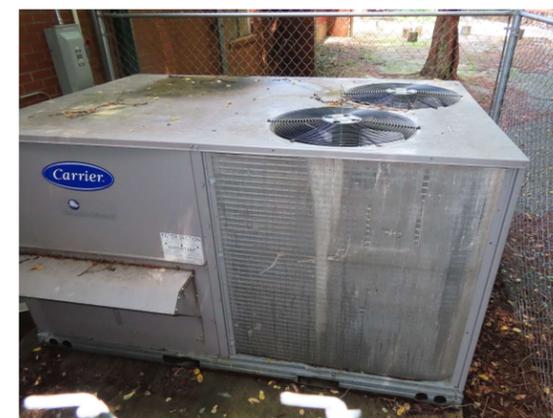
4	Air conditioning is provided by a combination of split system units, package units, and air handling units with chilled and hot water coils. The package unit was manufactured by Carrier in 2013 with a rated capacity of 7.5-tons. Based on the age of the split system, it is recommended to budget for the replacement of the package unit in the late-term.	Replace 7.5-ton Carrier package unit.	IV	CR	4	4	4	5	17	Low	20	9	7.5	TON	\$35,750									\$268,125	\$268,125

Carrier packaged Unit.

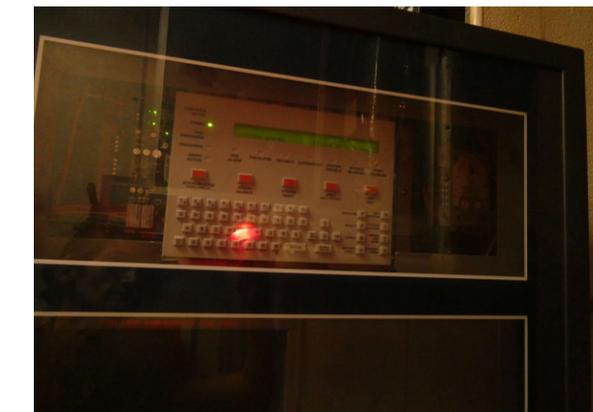
Fire & Life Safety Required																											
1	A fire detection and alarm system is provided within the building. The system is NFS-320 manufactured by Notifier. The panel is reportedly still supported by the manufacturer. However, given the potential for component obsolescence, it is recommended to upgrade the fire alarm panel during the study period.	Replace/upgrade the fire alarm control panel, annunciator panel, and as needed devices.	III	CR	3	4	4	4	15	Medium	15	4	1	EA	\$25,000				\$25,000							\$25,000	
Conveyance Systems Required																											
1	The building has no conveyance systems.	N/A																								\$0

NFS-320 fire alarm control panel (FACP).
