REPORT OF FACILITY CONDITION ASSESSMENT

Brevard Middle School

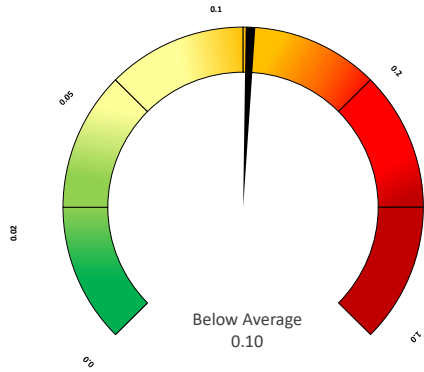
10 Year Facility Condition Index

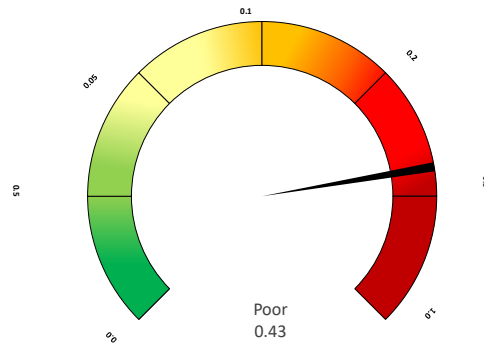
FCI Range	Condition Description
0.00 – 0.02	Excellent condition, typically new construction
0.02 – 0.05	Good Condition, renovations occur on schedule
0.05 – 0.1	Fair Condition, in need of normal renovation
0.1 – 0.2	Below average condition, major renovation required
0.2 – 0.5	Poor condition, total renovation needed
0.5 – 1	Complete facility replacement indicated

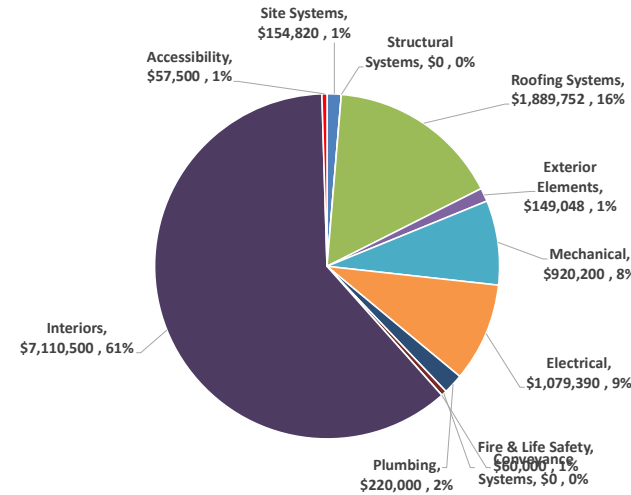
Expenditures by Deficiency Category

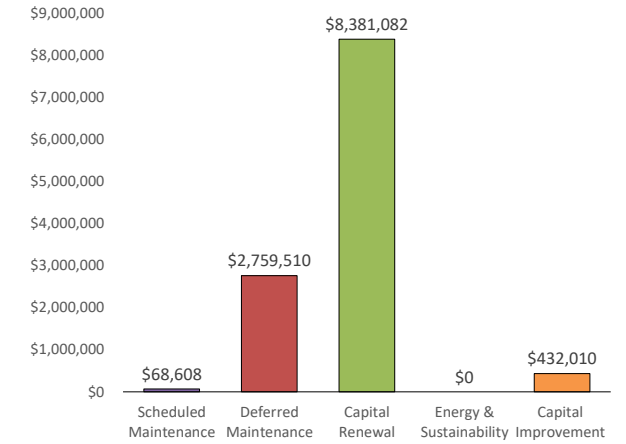
Expenditures by Risk

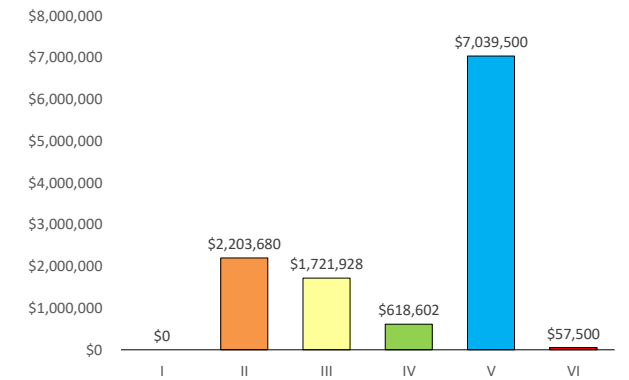
Risk	Definition
Critical	Critical (4-8)
High	High (9-13)
Medium	Medium (14-16)
Low	Low (17-20)

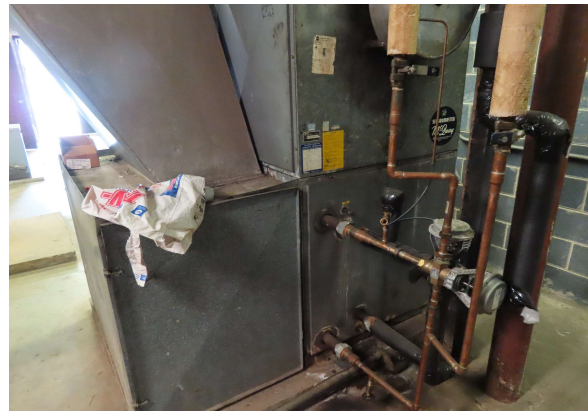
Vintage McQuay air handling unit in the boiler room.

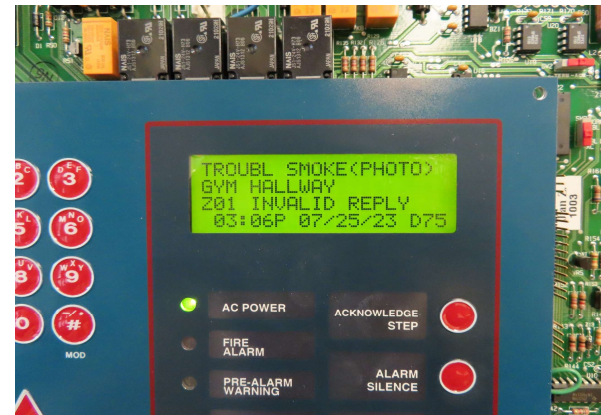
Obsolete fire alarm control panel with noted trouble alarms.

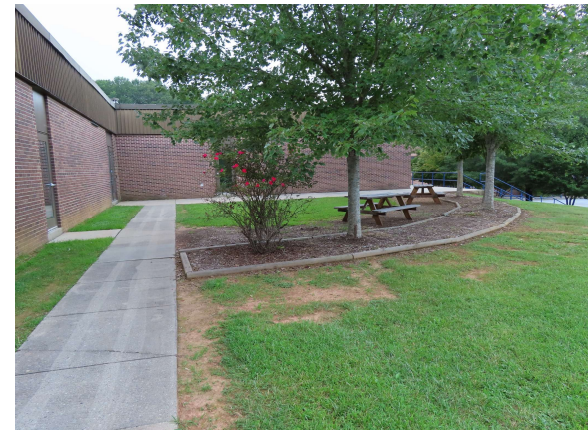
Landscaped area that holds water in heavy rain

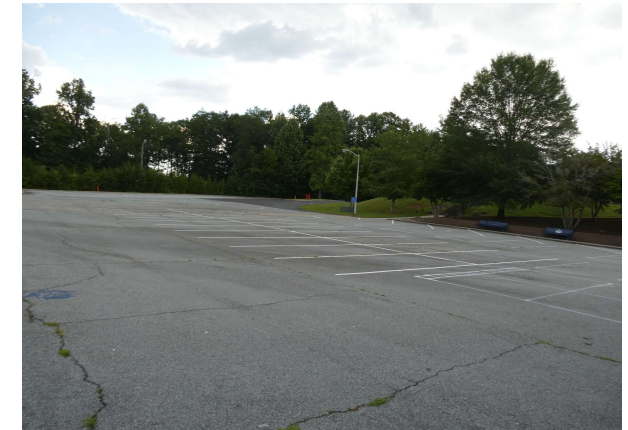
Asphalt parking lot with minor cracking.

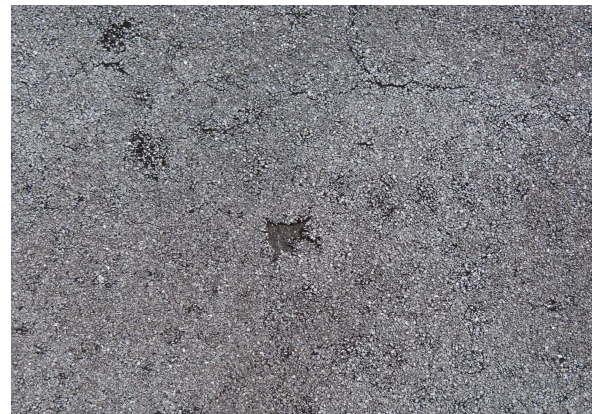
Deterioration of the built-up roof cap sheet.

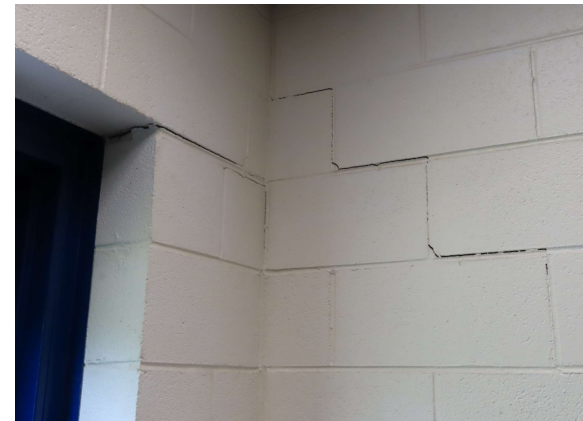
Painted CMU walls with stairstep cracking which should be monitored.

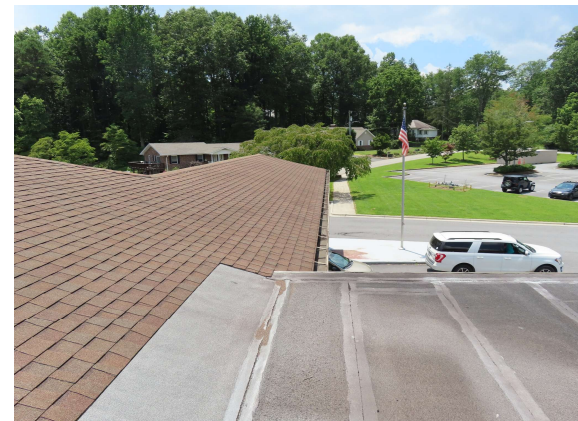
Low slope built up asphalt shingle roof

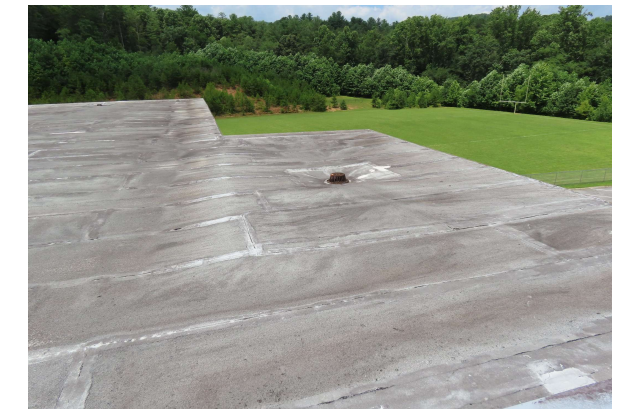
Failed seams noted at the built-up roof over the gym.

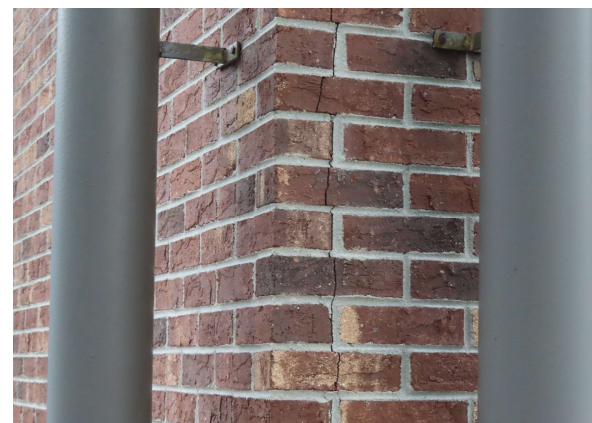
Exterior brick walls and vertical cracking

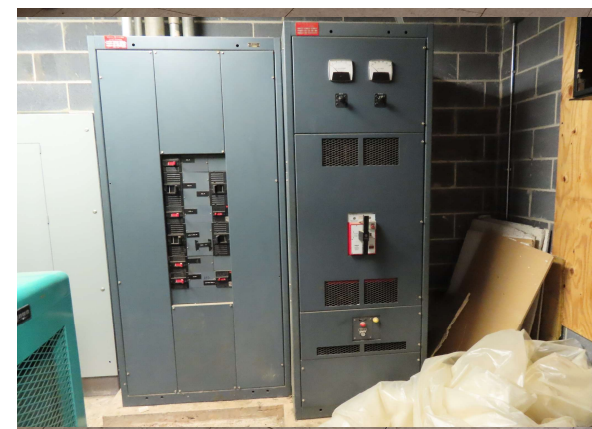
Obsolete electrical components, including main switch.
