P Piper Roofing

RE: Arch Repairs at Brevard High School

Following is the requested proposal for work associated with the arches of Brevard High School's old gymnasium and cafeteria. Please reference the following satellite photo and pictures for additional clarification.

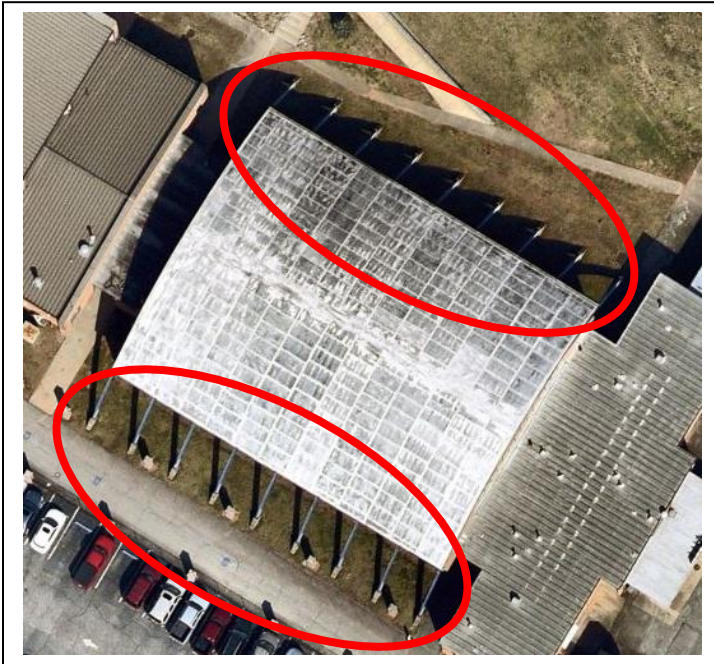
Old Gym
(18 total – 9 each side)

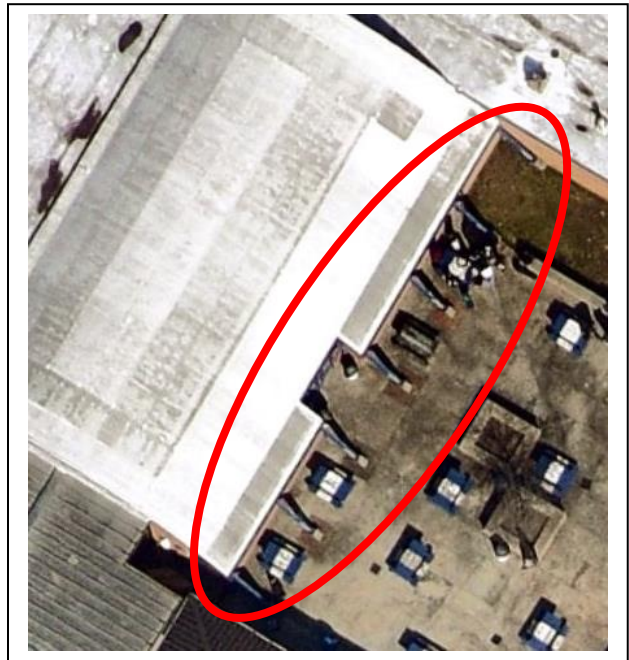
Cafeteria
(7 total – all on inside courtyard side)

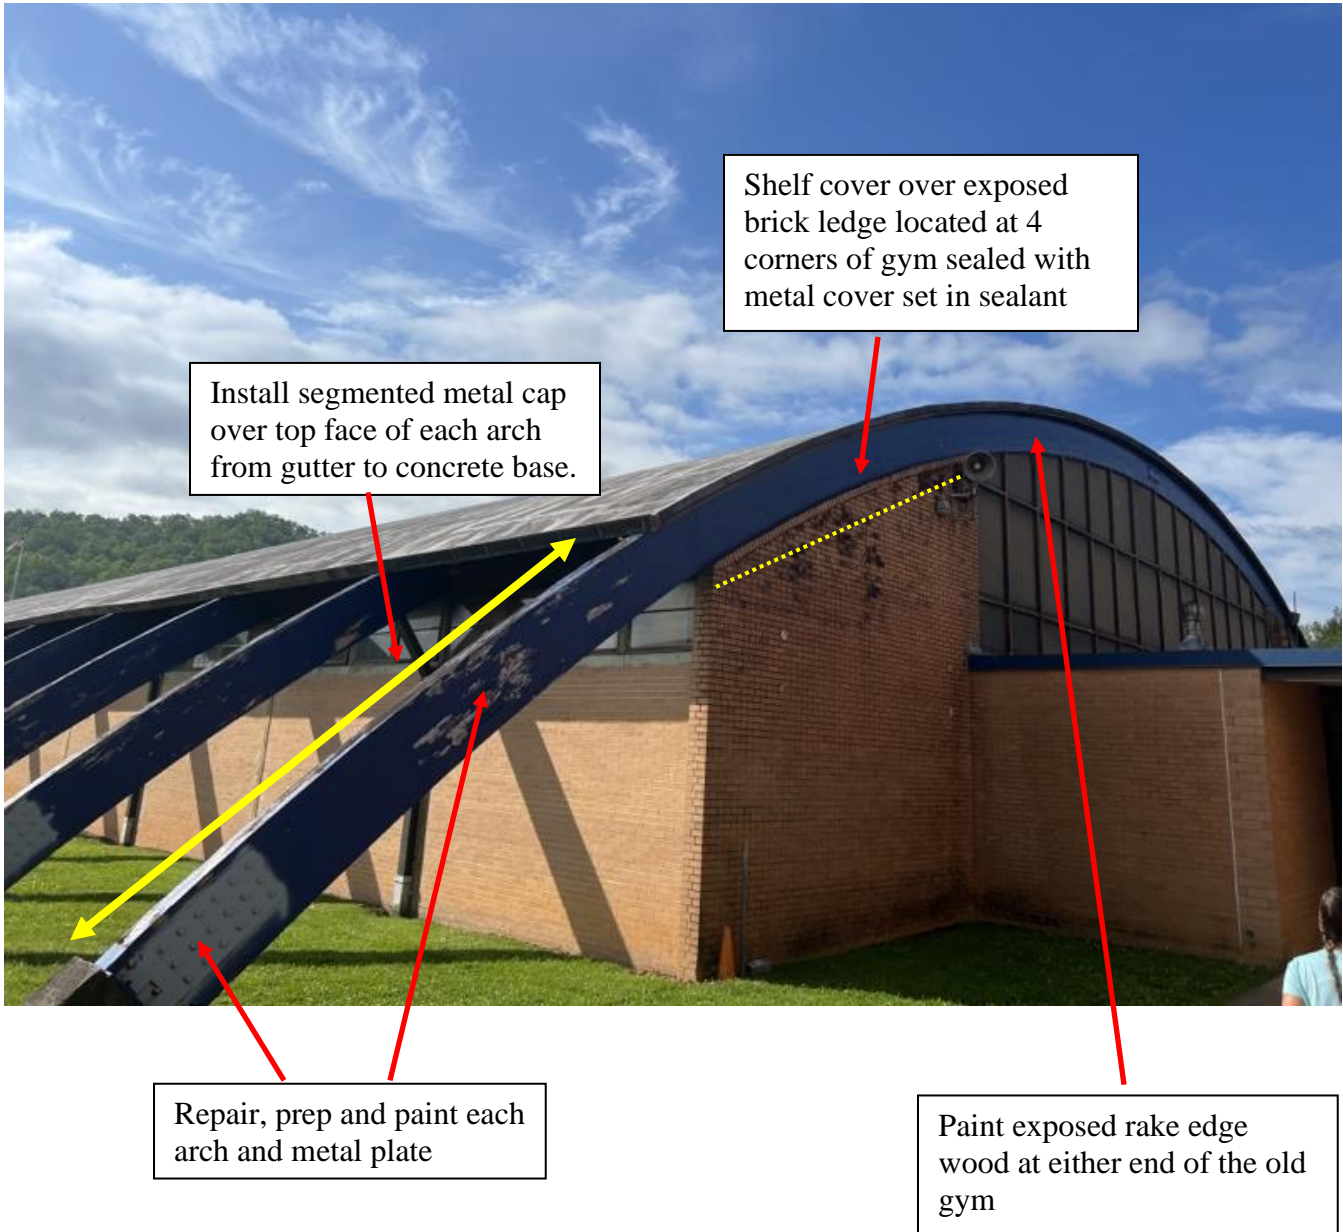
Gym

Painting, prep, repairs and metal work includes the following areas:

- Shop fabricate and install segmented shelf cover over exposed brick ledge at the 4 corners of the old gym where the arch transitions to the fascia wood face running from side to side.

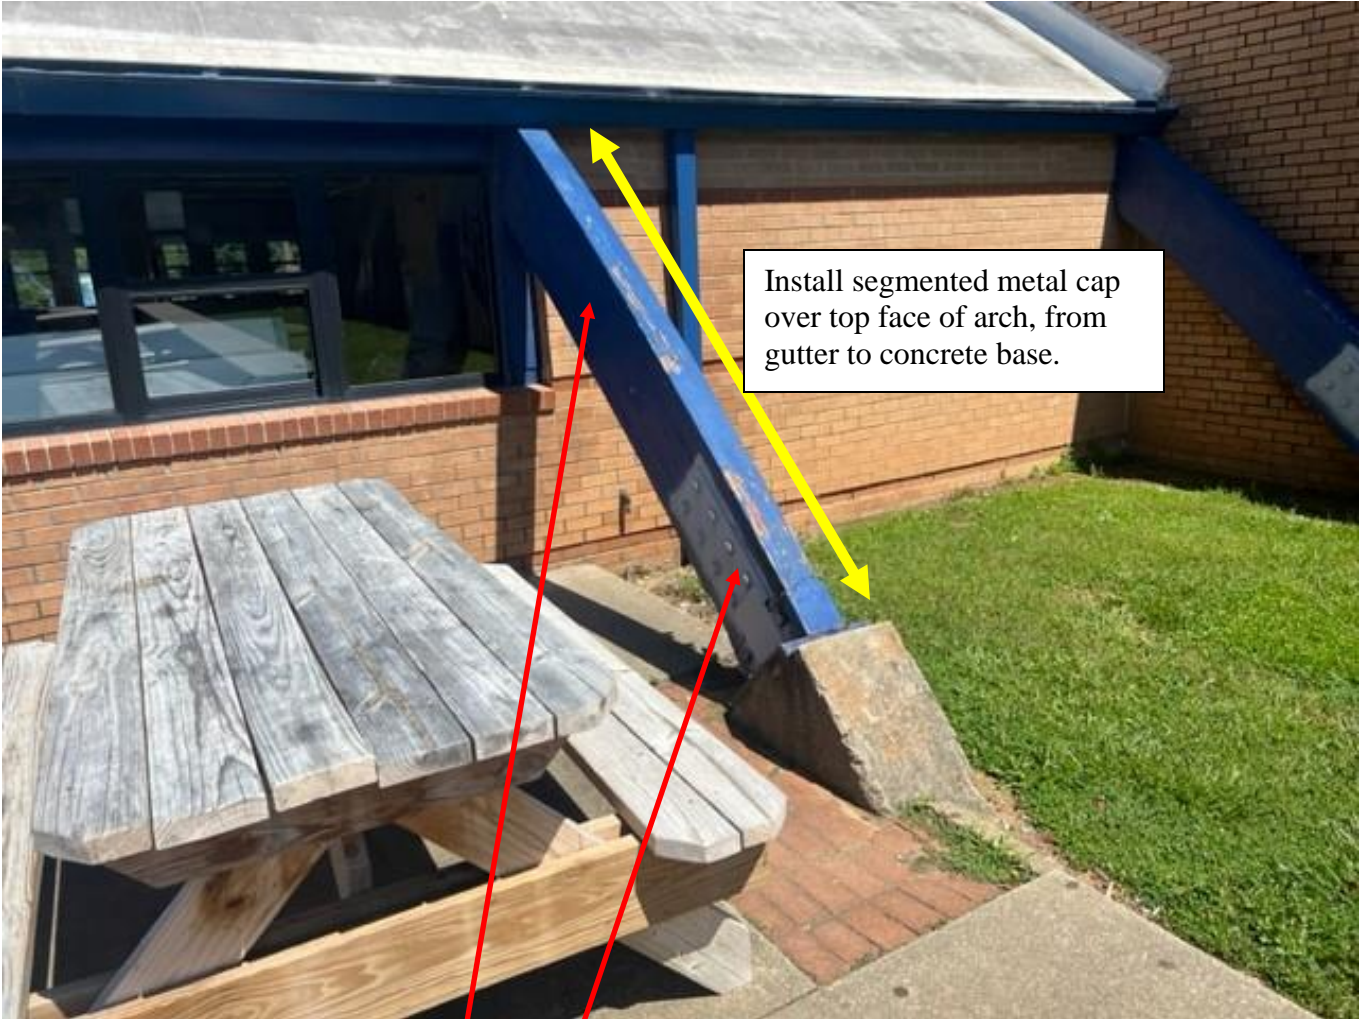
Cafeteria

Install segmented metal cap over top face of arch, from gutter to concrete base.

Repair, prep and paint each arch and metal plate
